PROPOSED DEVELOPMENT HAGSHAW LDES LTD LAND AT CONEXUS WEST WEST OF JUNCTION 11, M74, COALBURN LANARK

DESK STUDY REPORT

E13224 NL/NJH

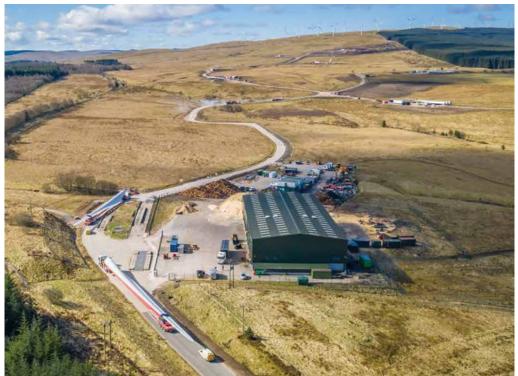
Photograph looking south showing the biomass plant with the northern parcel and the southern parcel located on the opposite side of the access road. Wind turbine components during delivery are shown in the photograph.

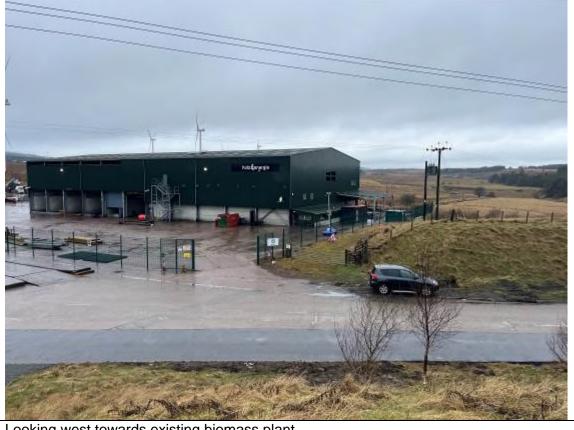
Looking west towards existing biomass plant.

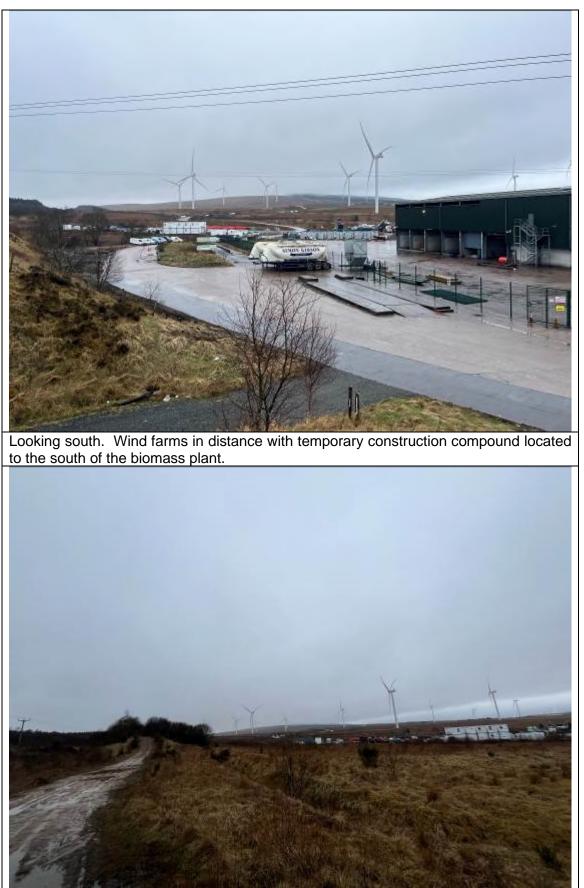
Looking south from north-eastern corner showing former railway embankment and temporary compound area.

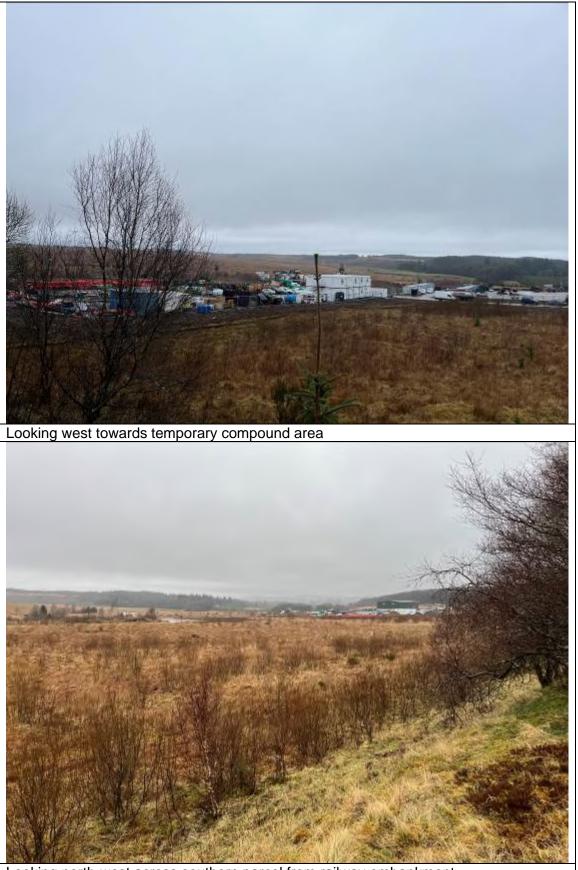
Looking north-west across southern parcel from railway embankment

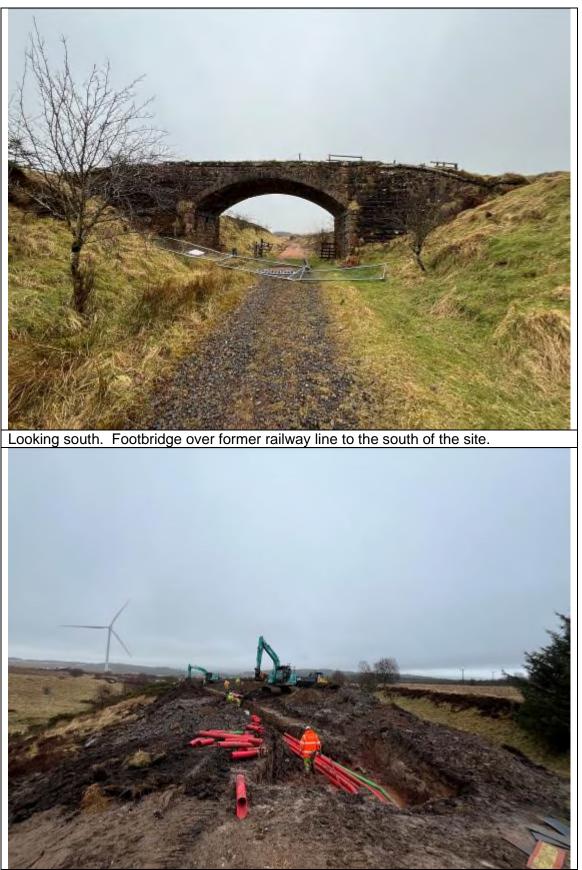
Area adjacent to southern boundary of site. Current works ongoing to lay electricity cables.

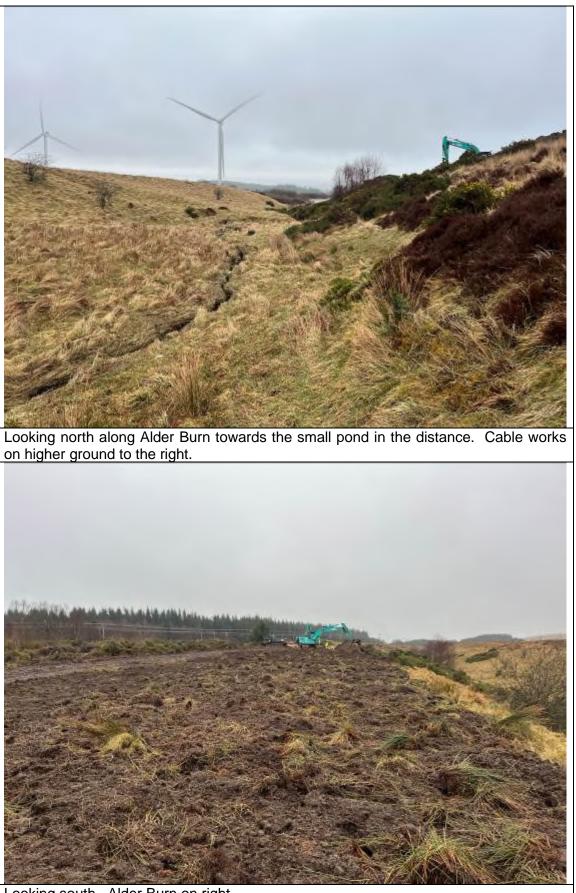
Looking south. Alder Burn on right.

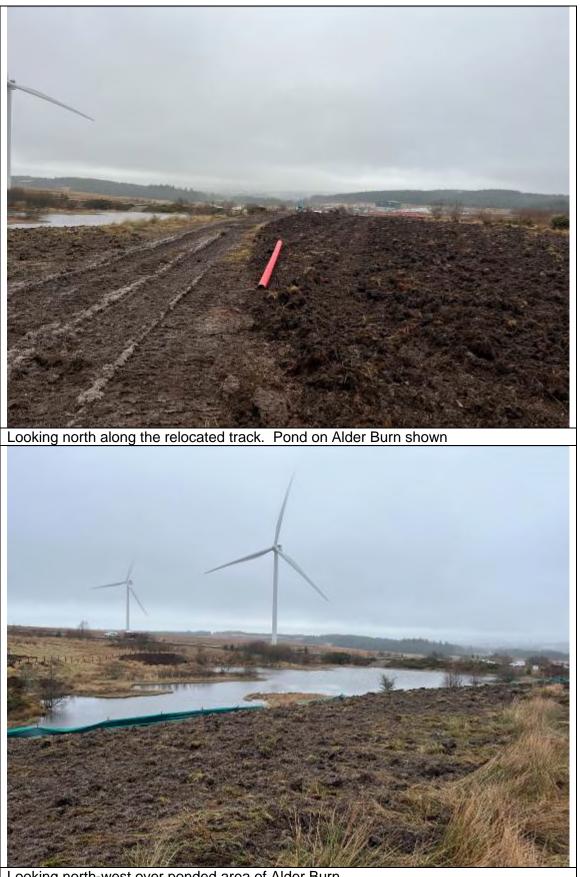
Looking north-west over ponded area of Alder Burn

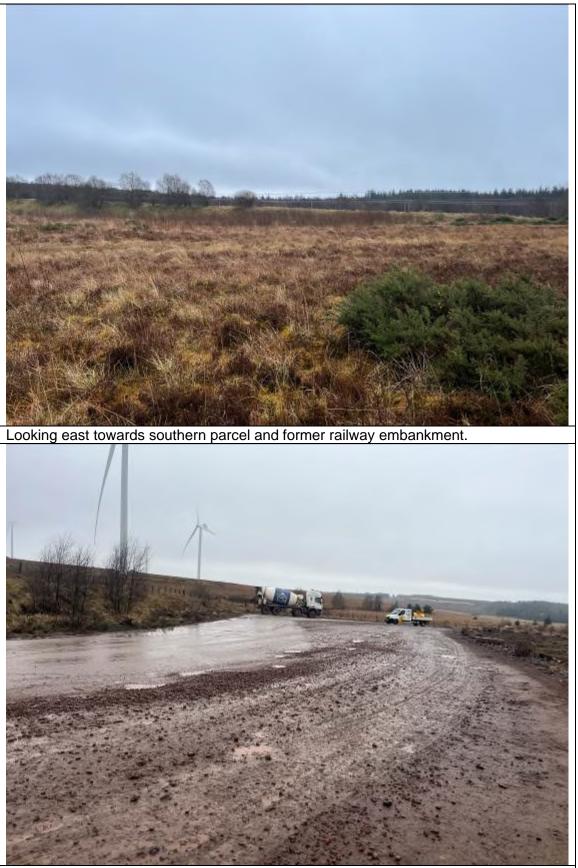
Looking west along access road between northern and southern parcels.

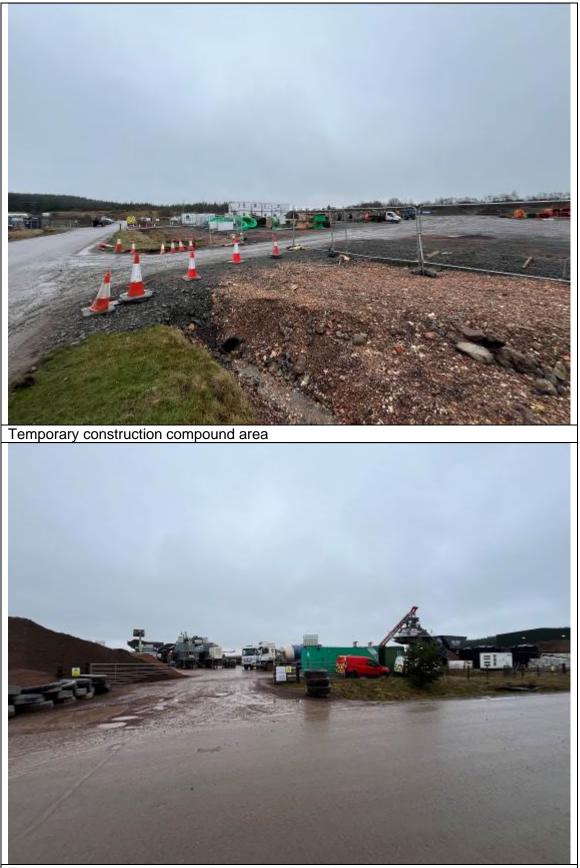
Temporary compound area and concrete mixing plant.

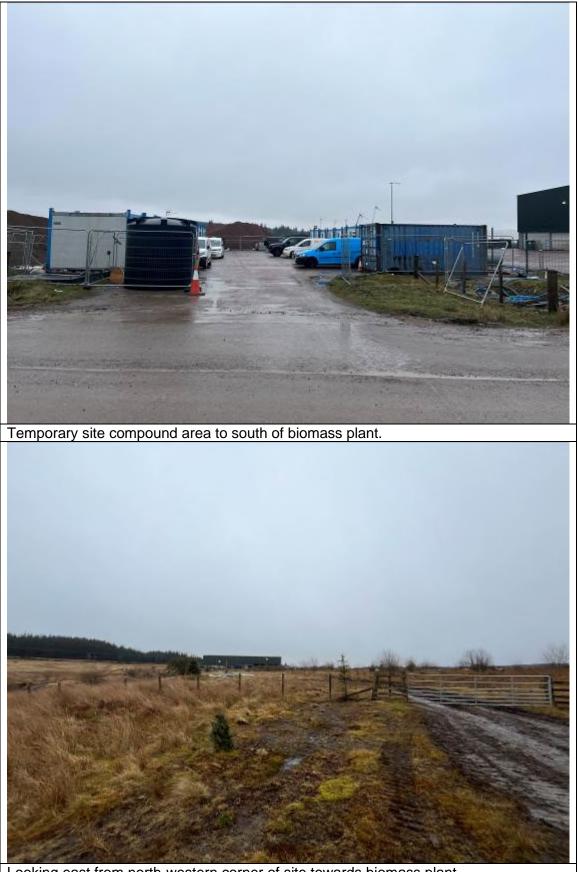
Looking east from north-western corner of site towards biomass plant.

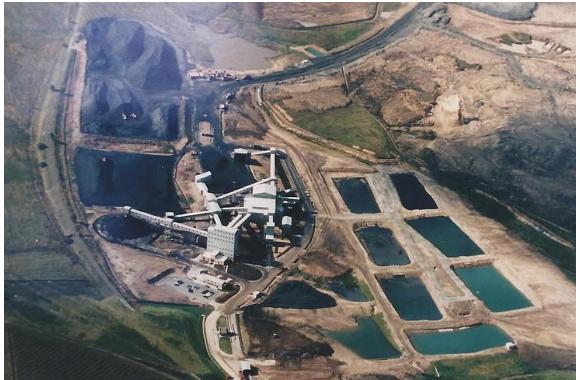
View looking south with the northern parcel of land occupied by settlement lagoons, wash plant and storage of coal on the southern parcel of land with the dismantled railway line clearly visible. Photograph (circa 1996) from Jim Hamilton Coalburn Heritage Society Website.

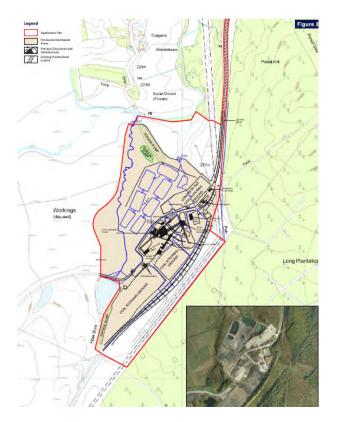
Extract of plan taken from planning application CL/17/0157 showing the previous coal processing facility layout in relation to the wider planning application boundary. The northern and southern parcels which will contain the LDES proposed are located within this.
