Technical Appendix 8.1: Schedule of Watercourse Crossings

Hagshaw Energy Cluster Western Expansion

3R Energy Solutions Ltd

SLR Consulting Limited

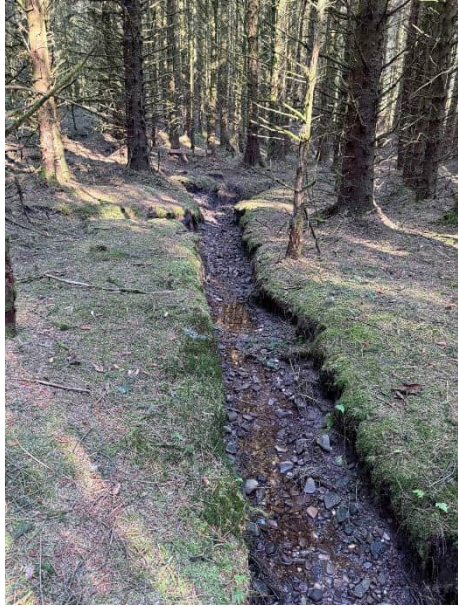
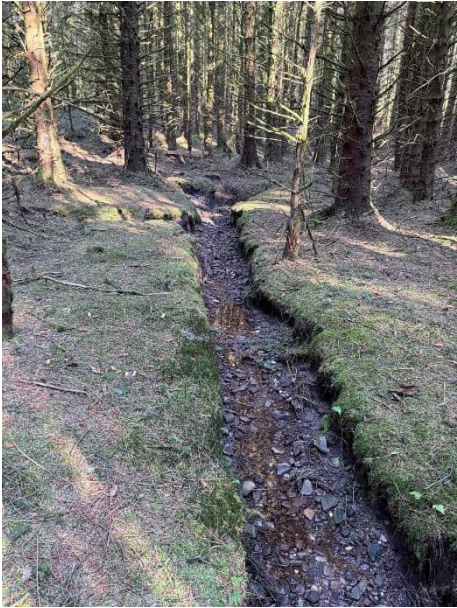
Watercourse Crossing ID	WX01
Watercourse Crossing Details	<p>Grid Reference: E 266604/ N 635522</p> <p>Status: New</p> <p>Watercourse Width: 1.0 m</p> <p>Watercourse Depth: 0.1 m</p> <p>Notes: Watercourse was not monitored during hydrology survey however approx. measurements and photographs provided from Applicant walkover.</p>
Photograph Looking Upstream

Potential Crossing Type Likely Required CAR Authorisation	Culvert Registration

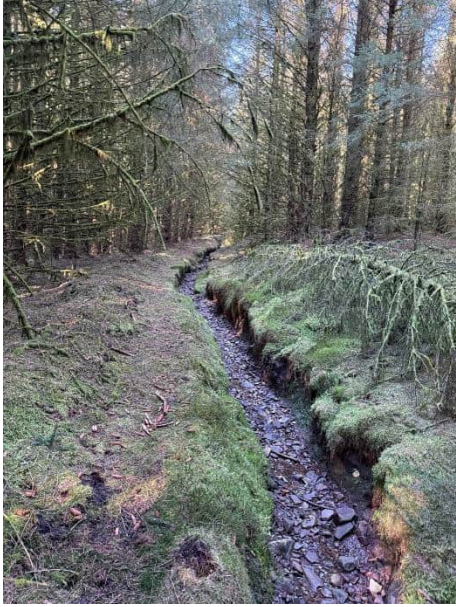
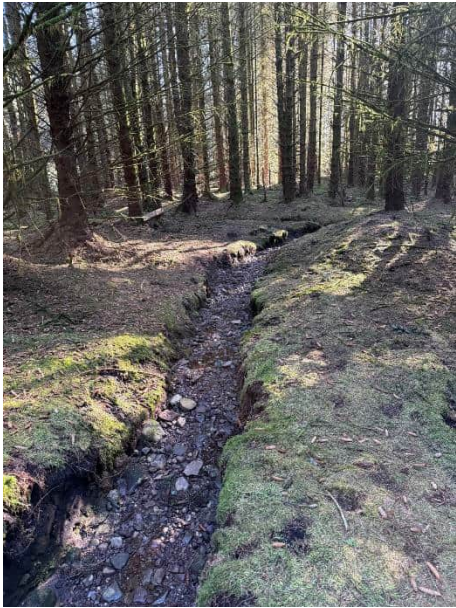
Watercourse Crossing ID	WX02
Watercourse Crossing Details	<p>Grid Reference: E 266135 / N 635803</p> <p>Status: New</p> <p>Watercourse Width: 1.0 m</p> <p>Watercourse Depth: 0.1 m</p> <p>Notes: Proposed crossing location is noted approximately 100 m upstream of WX01. Watercourse was not monitored during hydrology survey however approx. measurements and photographs provided from Applicant walkover.</p>
Photograph Looking Upstream

Potential Crossing Type Likely Required CAR Authorisation	Culvert Registration

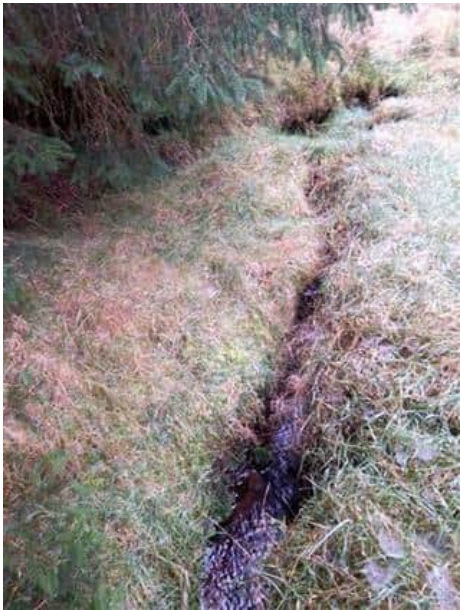
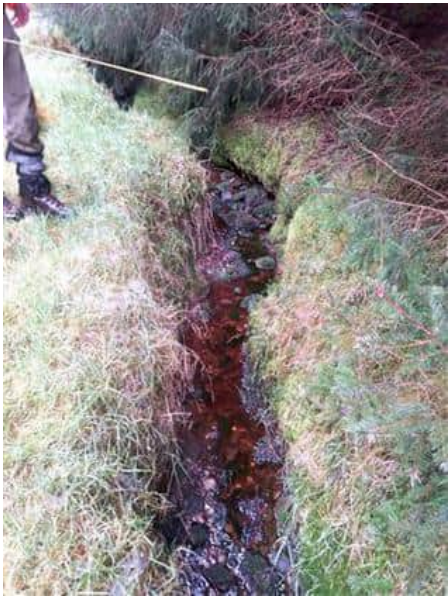
Watercourse Crossing ID	WX03
Watercourse Crossing Details	Grid Reference: E 266604 / N 635522 Status: New Watercourse Width: 0.5 m Watercourse Depth: 0.1 m Notes: None.
Photograph Looking Upstream

Potential Crossing Type Likely Required CAR Authorisation	Culvert Registration

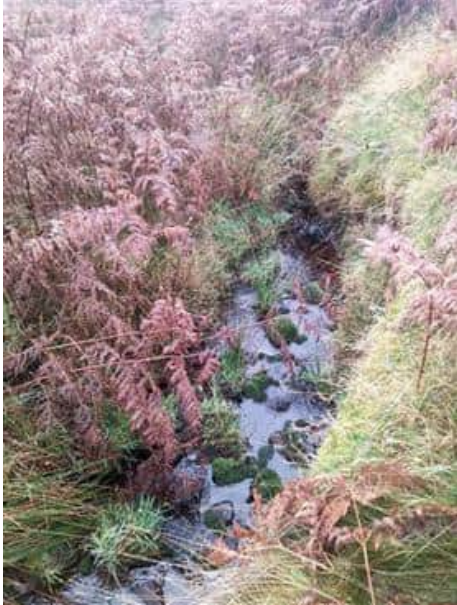
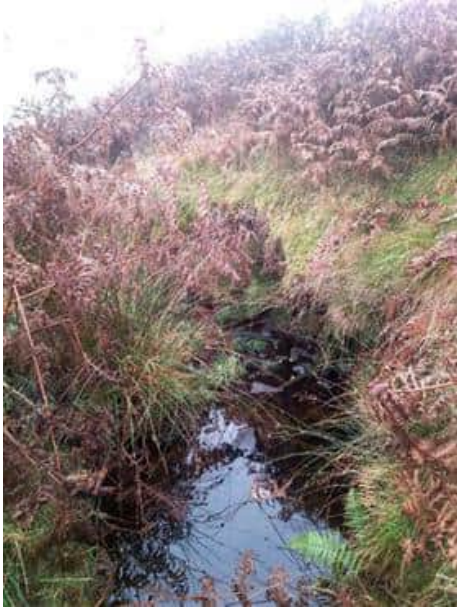
Watercourse Crossing ID	WX04
Watercourse Crossing Details	Grid Reference: E 267571 / N 634302 Status: New Watercourse Width: 1 to 1.5 m Watercourse Depth: 0.4 m Notes: Watercourse located in a slightly deeper channel which is up to 1.2 m deep.
Photograph Looking Upstream

Potential Crossing Type Likely Required CAR Authorisation	Culvert Registration

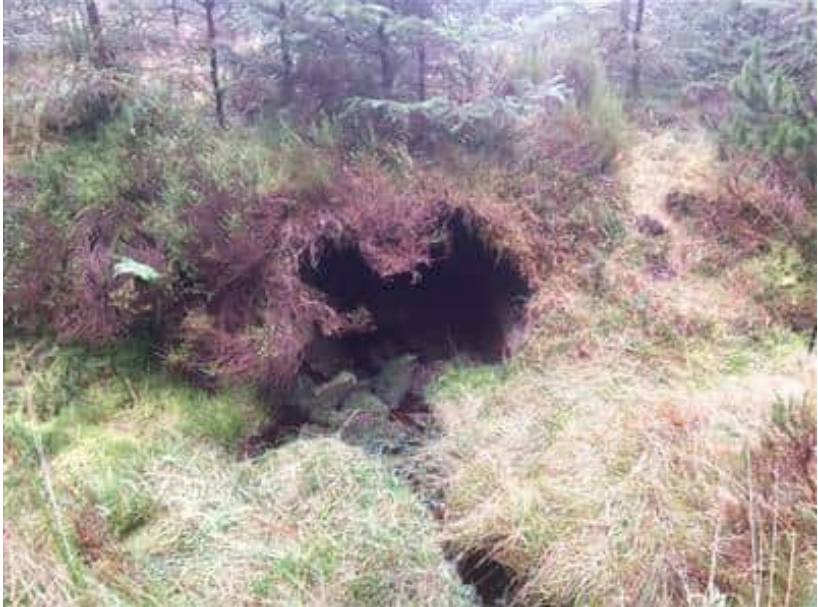
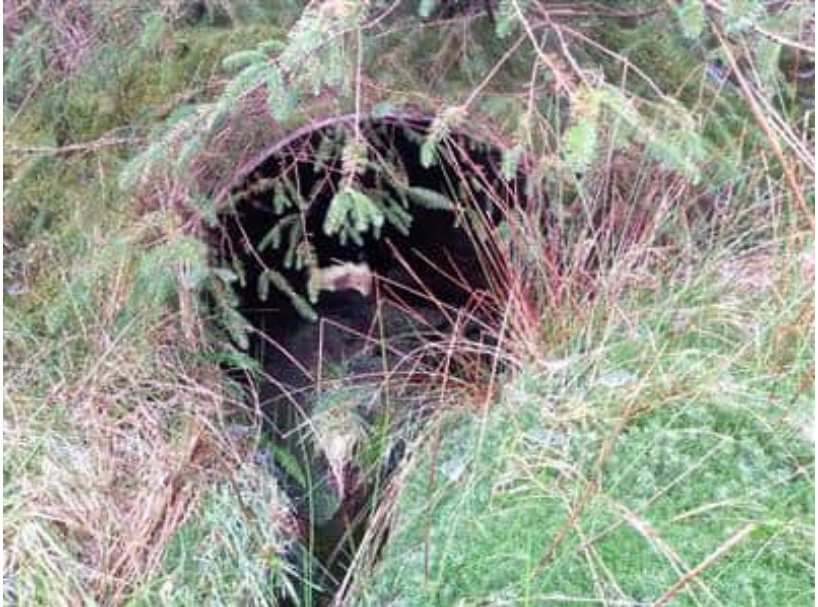
Watercourse Crossing ID	WX05
Watercourse Crossing Details	<p>Grid Reference: E 267879 / N 634703</p> <p>Status: Existing to be upgraded</p> <p>Crossing Type: Steel circular culvert</p> <p>Crossing Size: 1.5 m diameter</p> <p>Watercourse Width: 0.4 to 1 m</p> <p>Watercourse Depth: 0.1 m</p> <p>Notes: Watercourse width noted to pool up to 1 m wide.</p>
Photograph of Culvert Entrance Looking from Upstream

<p>A photograph showing the entrance of a culvert from an upstream perspective. The culvert is a dark, circular opening in a grassy area, surrounded by dense vegetation and trees. The water level is visible just inside the entrance.</p>
Photograph of Culvert Exit Looking from Downstream

<p>A photograph showing the exit of a culvert from a downstream perspective. The culvert is a dark, circular opening in a grassy area, surrounded by dense vegetation and trees. The water level is visible just inside the exit.</p>

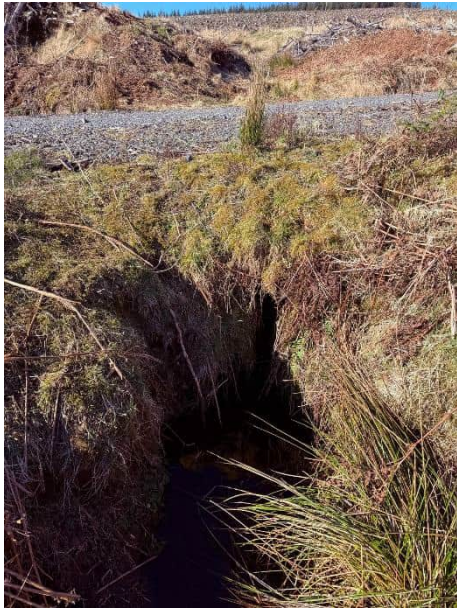
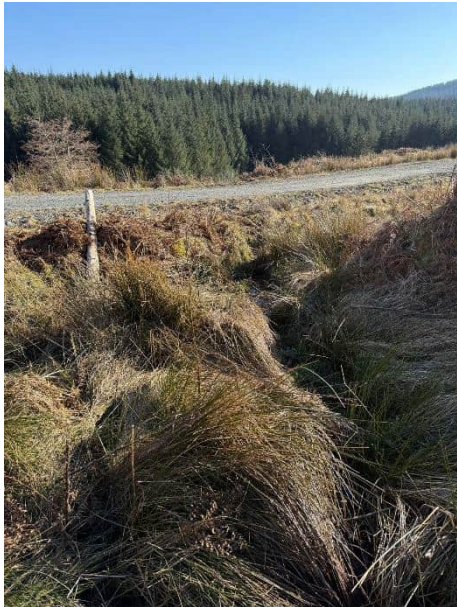
Watercourse Crossing ID	WX06
Watercourse Crossing Details	Grid Reference: E 268061 / N 633972 Status: Existing Notes: Watercourse was not monitored during hydrology survey however photographs provided from Applicant walkover.
Photograph Looking Upstream

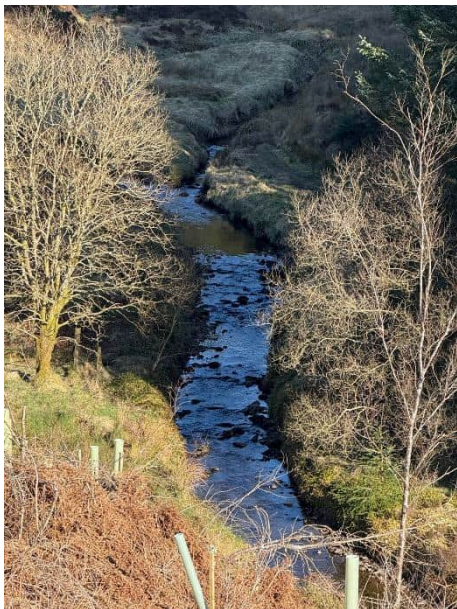
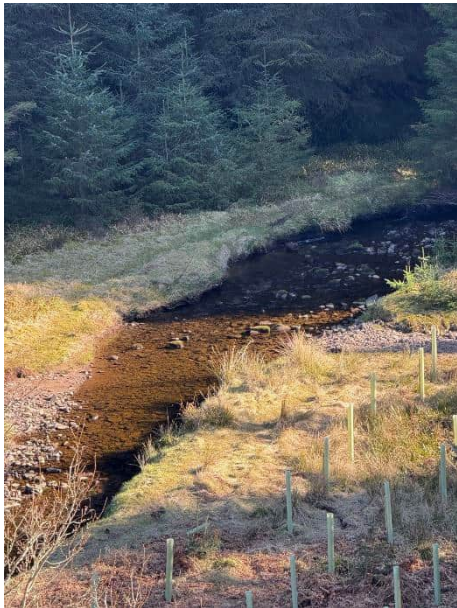
Watercourse Crossing ID	WX07
Watercourse Crossing Details	<p>Grid Reference: E 268241 / N 633989</p> <p>Status: New</p> <p>Watercourse Width: 3.0 m</p> <p>Watercourse Depth: 0.2 m</p> <p>Notes: At crossing location watercourse is approximately 10 m wide and with a mapped floodplain which is up to approximately 50 m wide on the SEPA flood maps. Additional measurements and photographs provided by Applicant as not monitored during hydrology survey, although as noted in Section 1.0 the project engineers have visited the crossing location.</p>
Photograph Looking Upstream

<p>A photograph showing a narrow watercourse flowing through a wooded area. The water is dark and reflects the surrounding trees. The banks are covered with dry, brown vegetation and some green moss. The trees are mostly bare, suggesting a late autumn or winter setting.</p>
Photograph Looking Downstream

<p>A photograph showing a watercourse flowing through a wooded area. The water is dark and reflects the surrounding trees. The banks are covered with dry, brown vegetation and some green moss. The trees are mostly bare, suggesting a late autumn or winter setting.</p>

Potential Crossing Type Likely Required CAR Authorisation	Oversized bottomless arch culvert Registration

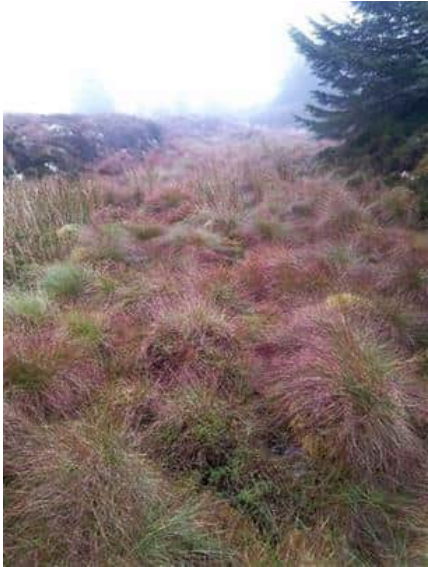
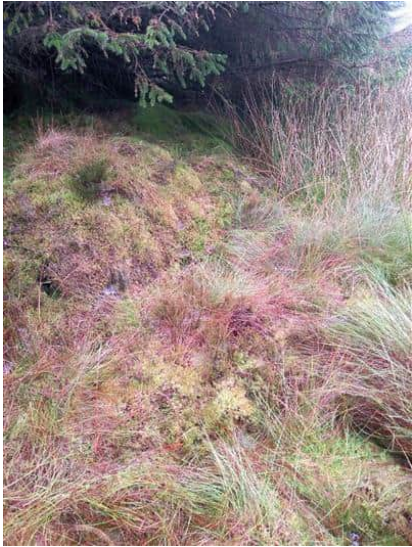
Watercourse Crossing ID	WX08
Watercourse Crossing Details	Grid Reference: E 270739 / N 634545 Status: New Watercourse Width: n/a Watercourse Depth: n/a Notes: No visible channel at crossing point during survey.
Photograph Looking Upstream

Potential Crossing Type Likely Required CAR Authorisation	Culvert Registration

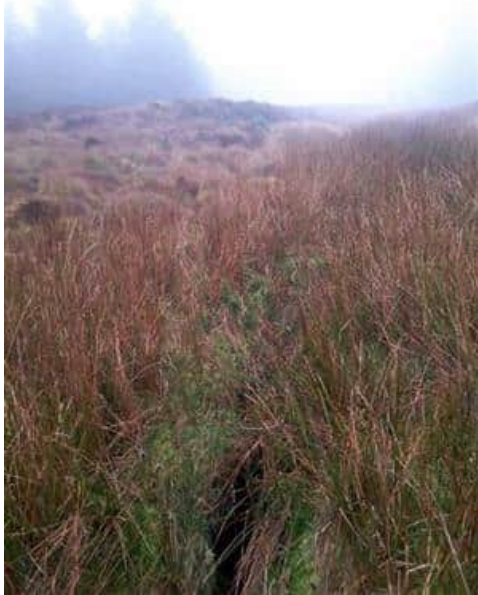
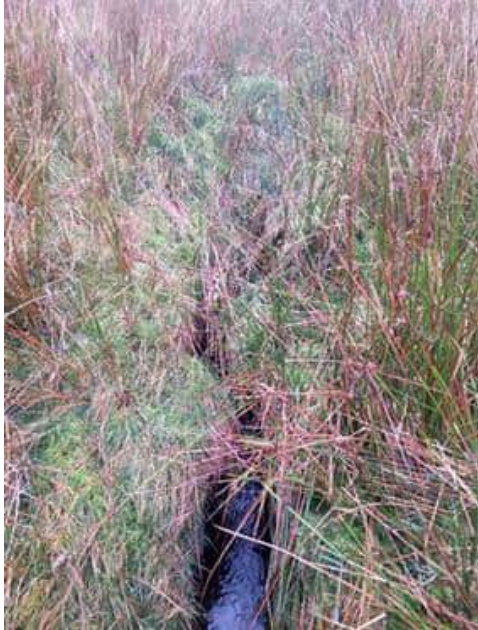
Watercourse Crossing ID	WX09
Watercourse Crossing Details	Grid Reference: E 270842 / N 634896 Status: New Watercourse Width: 0.3 m Watercourse Depth: 0.1 m Notes: None.
Photograph Looking Upstream

Potential Crossing Type Likely Required CAR Authorisation	Culvert Registration

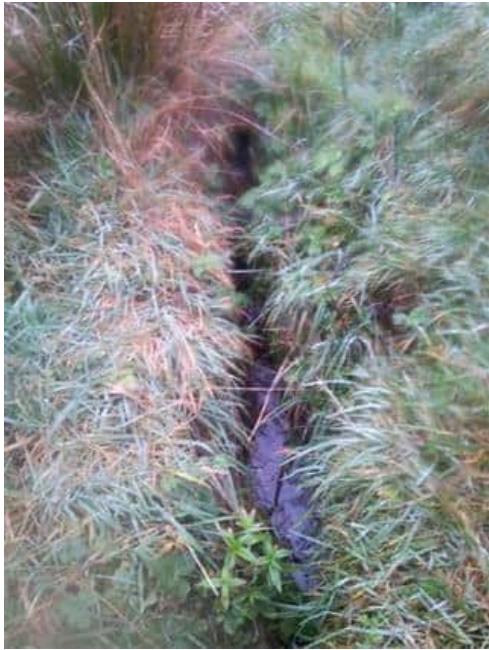
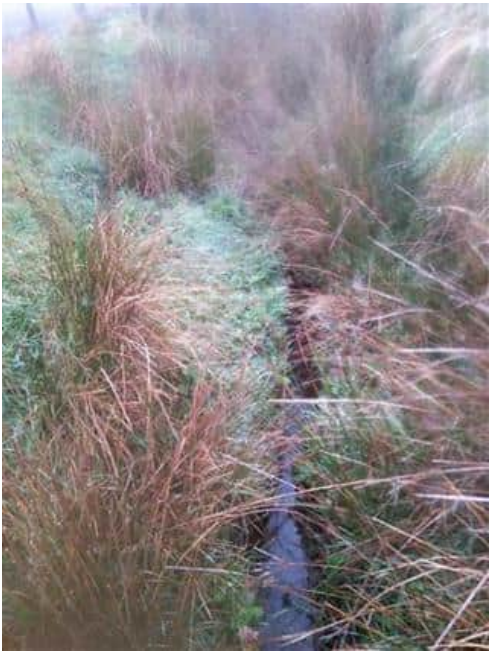
Watercourse Crossing ID	WX10
Watercourse Crossing Details	Grid Reference: E 269595 / N 629608 Status: New Watercourse Width: 0.3 m Watercourse Depth: 0.1 m Notes: None.
Photograph Looking Upstream

Potential Crossing Type Likely Required CAR Authorisation	Culvert Registration

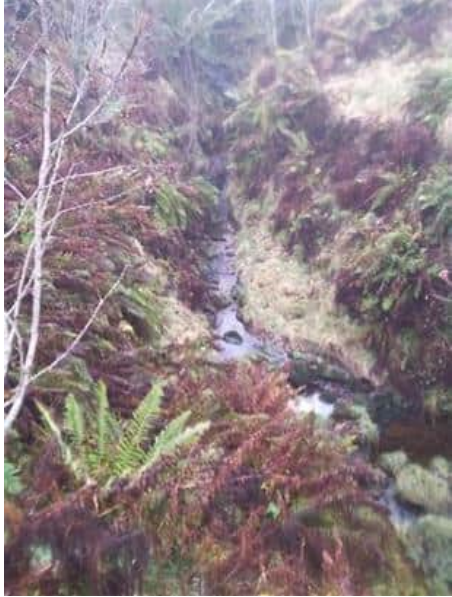
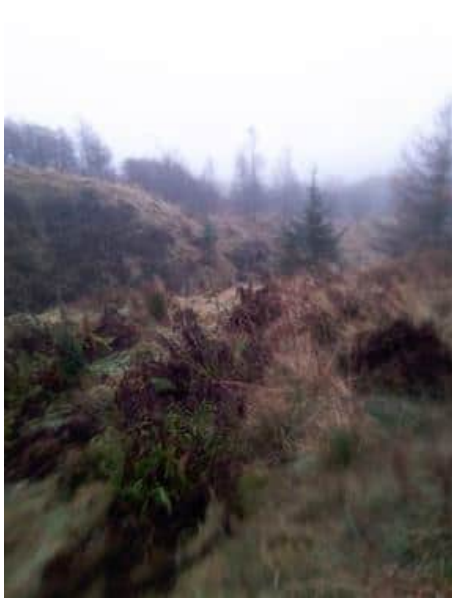
Watercourse Crossing ID	WX11
Watercourse Crossing Details	Grid Reference: E 269143 / N 629588 Status: New Watercourse Width: 0.4 – 1 m Watercourse Depth: 0.3 m Notes: Watercourse inaccessible at the proposed crossing point. Watercourse is located within an incised channel which is approximately 10 to 15 m deep.
Photograph Looking Upstream

Potential Crossing Type Likely Required CAR Authorisation	Oversized bottomless arch culvert Registration

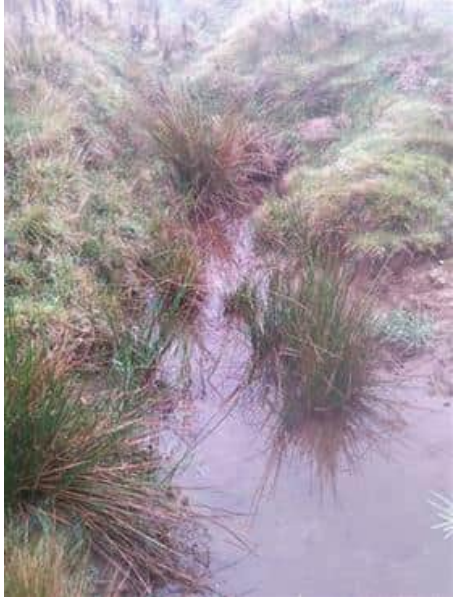
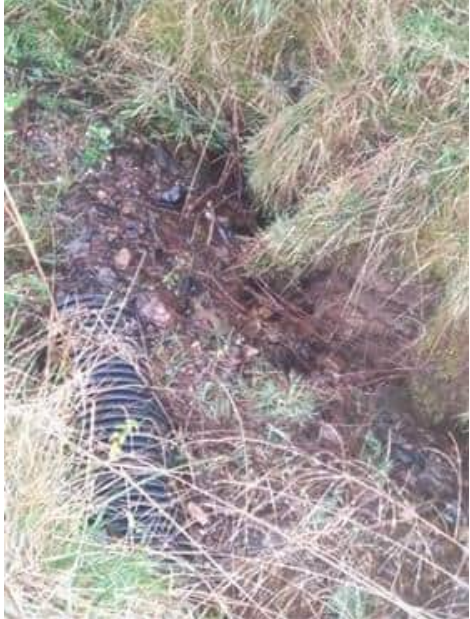
Watercourse Crossing ID	WX12
Watercourse Crossing Details	<p>Grid Reference: E 268478 / N 629342</p> <p>Status: Existing to be upgraded</p> <p>Crossing Type: Plastic circular culvert</p> <p>Crossing Size: 0.3 m diameter</p> <p>Watercourse Width: 0.5 m</p> <p>Watercourse Depth: 0.1 m</p> <p>Notes: Culvert entrance not found during survey. Ponding of water around channel indicated existing culvert potentially blocked.</p>
Photograph Looking Upstream

<p>A photograph showing a watercourse with tall, dry grasses and reeds growing along the banks. The water is murky and brown, and the overall scene is somewhat overcast.</p>
Photograph Looking Downstream

<p>A photograph showing a close-up view of a watercourse. The water is dark and murky, and there is a lot of debris, including sticks and leaves, floating in it. The banks are covered in tall, dry grasses.</p>

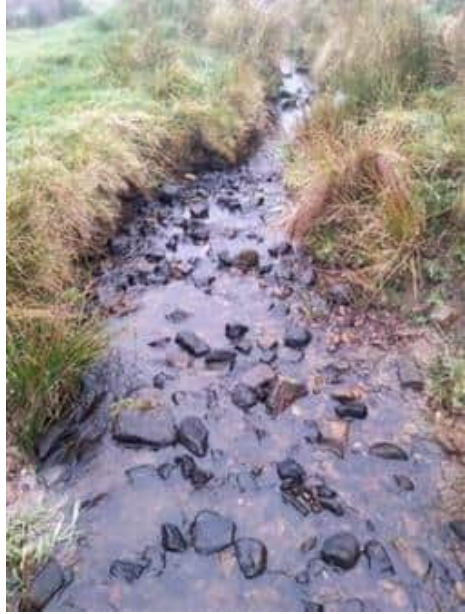
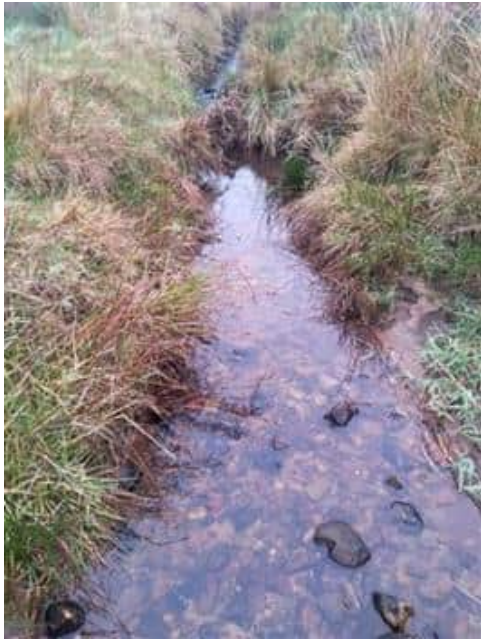
Watercourse Crossing ID	WX13
Watercourse Crossing Details	Grid Reference: E 268295 / N 629278 Status: New Watercourse Width: 0.5 to 1.5 m Watercourse Depth: 0.1 m Notes: Watercourse surveyed approximately 10 m downstream of proposed crossing point.
Photograph Looking Upstream

Potential Crossing Type Likely Required CAR Authorisation	Culvert Registration

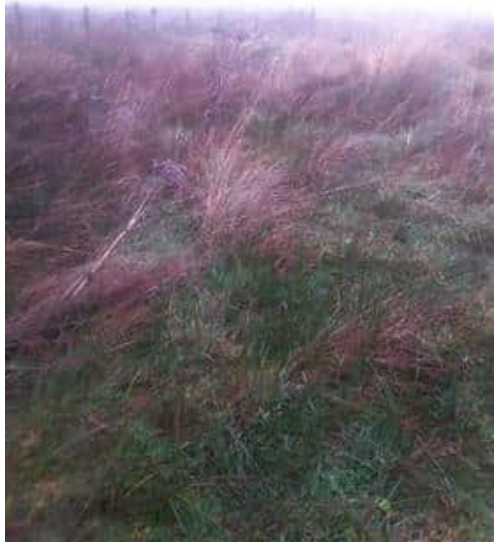
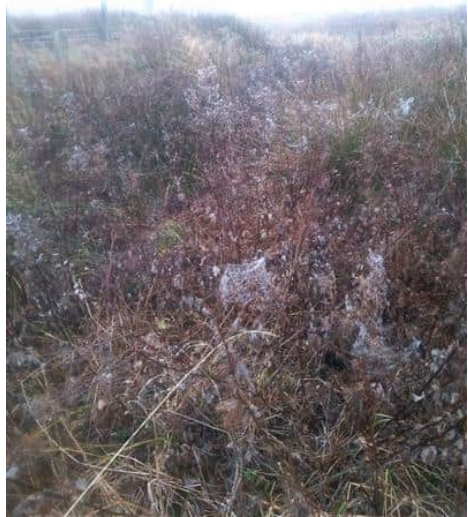
Watercourse Crossing ID	WX14
Watercourse Crossing Details	Grid Reference: E 267995 / N 629069 Status: New Watercourse Width: n/a Watercourse Depth: n/a Notes: No obvious channel. Slight trickle of water under vegetation.
Photograph Looking Upstream

Potential Crossing Type Likely Required CAR Authorisation	Culvert Registration

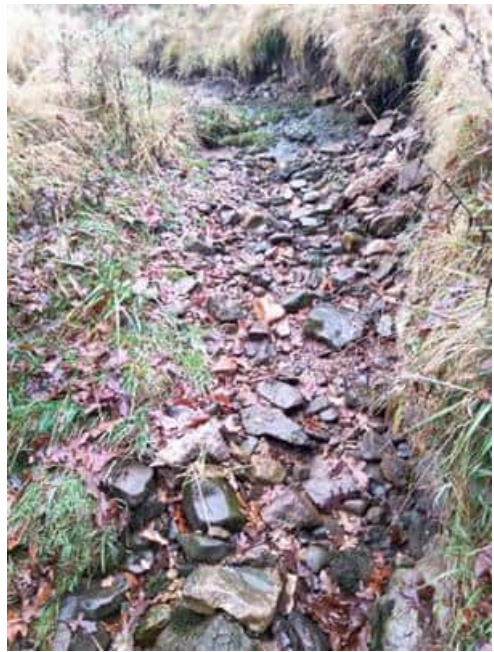
Watercourse Crossing ID	WX15
Watercourse Crossing Details	Grid Reference: E 267702 / N 629066 Status: New Watercourse Width: 1.5 to 2.5 m Watercourse Depth: 0.3 m Notes: Watercourse noted dry during survey.
Photograph Looking Upstream	 
Photograph Looking Downstream

Potential Crossing Type Likely Required CAR Authorisation	Oversized bottomless arch culvert Registration

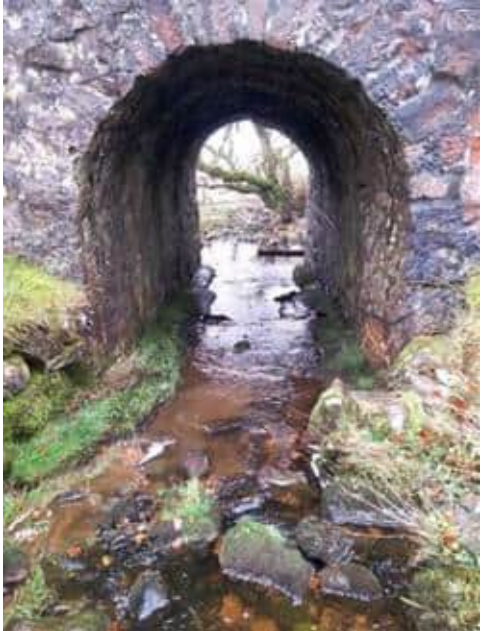
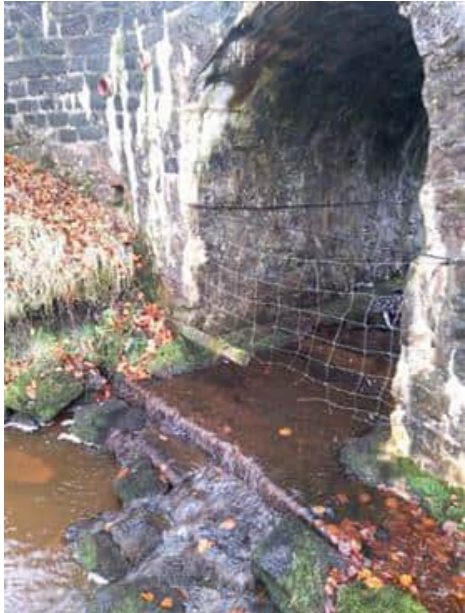
Watercourse Crossing ID	WX16
Watercourse Crossing Details	<p>Grid Reference: E 267230 / N 628846</p> <p>Status: Existing</p> <p>Crossing Type: Stone arch culvert</p> <p>Crossing Size: 2.1 m high and 1.8 m wide</p> <p>Watercourse Width: 2 m</p> <p>Watercourse Depth: 0.1 m</p> <p>Notes:</p>
Photograph of Culvert Entrance Looking from Upstream
