# **Technical Appendix 8.5**

## **Peat Landslide Hazard and Risk Assessment**

# TA 8.5 Peat Landslide Hazard and Risk Assessment

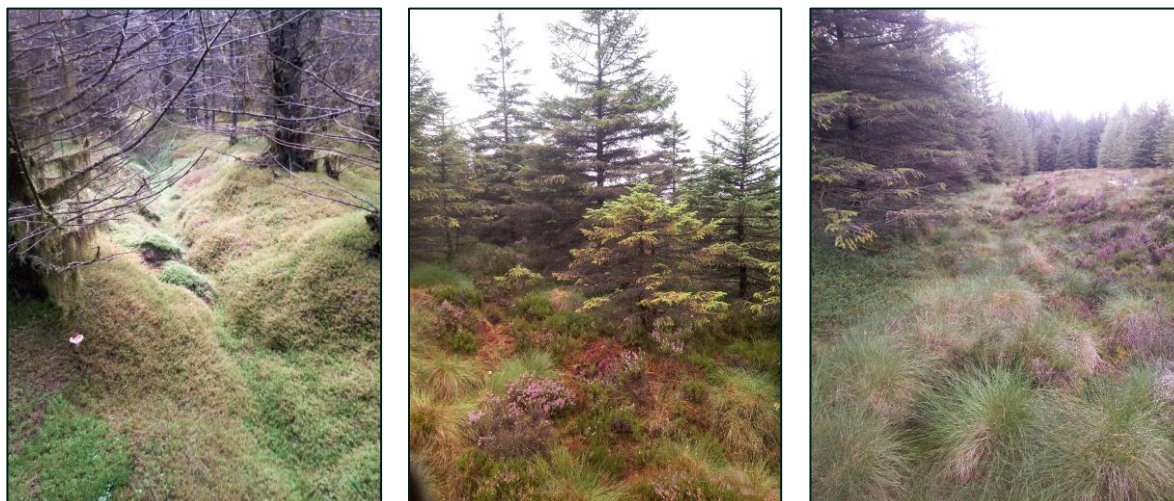
**Plate 4.1 – Northern Development Area ground conditions**

- 4.1.8 The survey results show that 43 % of probes identifying thin soils (<0.5 m), with 20.6 % of probe locations identified thick peat (>1 m), to a maximum depth of 3.0 m.
- 4.1.9 The results show that deep peat (>1 m) is present across much of the eastern part of the northern development area, on flat lying ground, towards the southern boundary. The western part of the northern development area is largely absent of peat (>0.5 m). The average probe depth in the northern development area is 0.7 m. General ground conditions of the northern development area are shown in **Plate 4.1**.

- 4.1.10 There are limited peat deposits in the southern development area with an average probe depth of 0.3 m.
- 4.1.11 The Proposed Development infrastructure has been through several design iterations, informed by site survey, and following consultation with SEPA. The Proposed Development infrastructure has avoided areas of deep peat so far as practicable, whilst taking into consideration other technical and environmental constraints. The existing forestry track network has been utilised where possible, and where tracks cross areas of peat in excess of 0.8 m, floated construction is proposed.

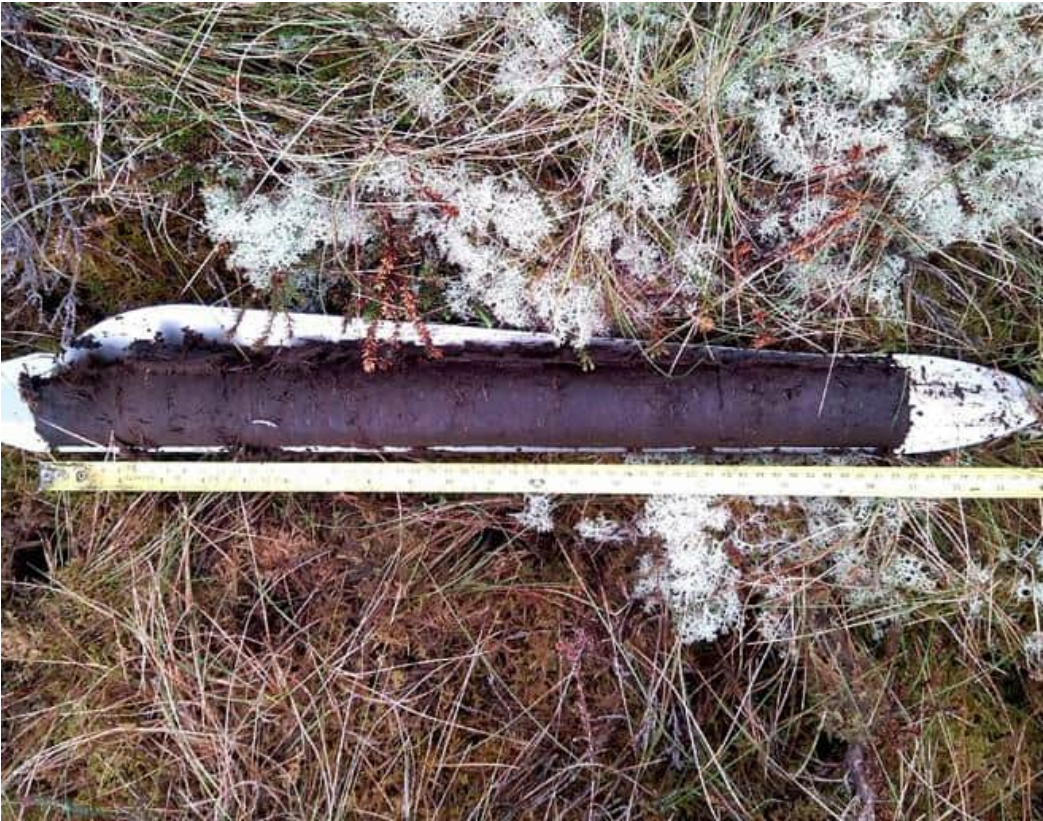
| ID: | Photo 1 | Von Post Classification: | H2 |

| Location: | 270426, 634279 | Underlying Substrate: | N/A |
| Description: | Auger Location 1 | Logged By: | BN / AD |
| Depth (m): | 0 – 0.5 | Date: | 24/05/2024 |

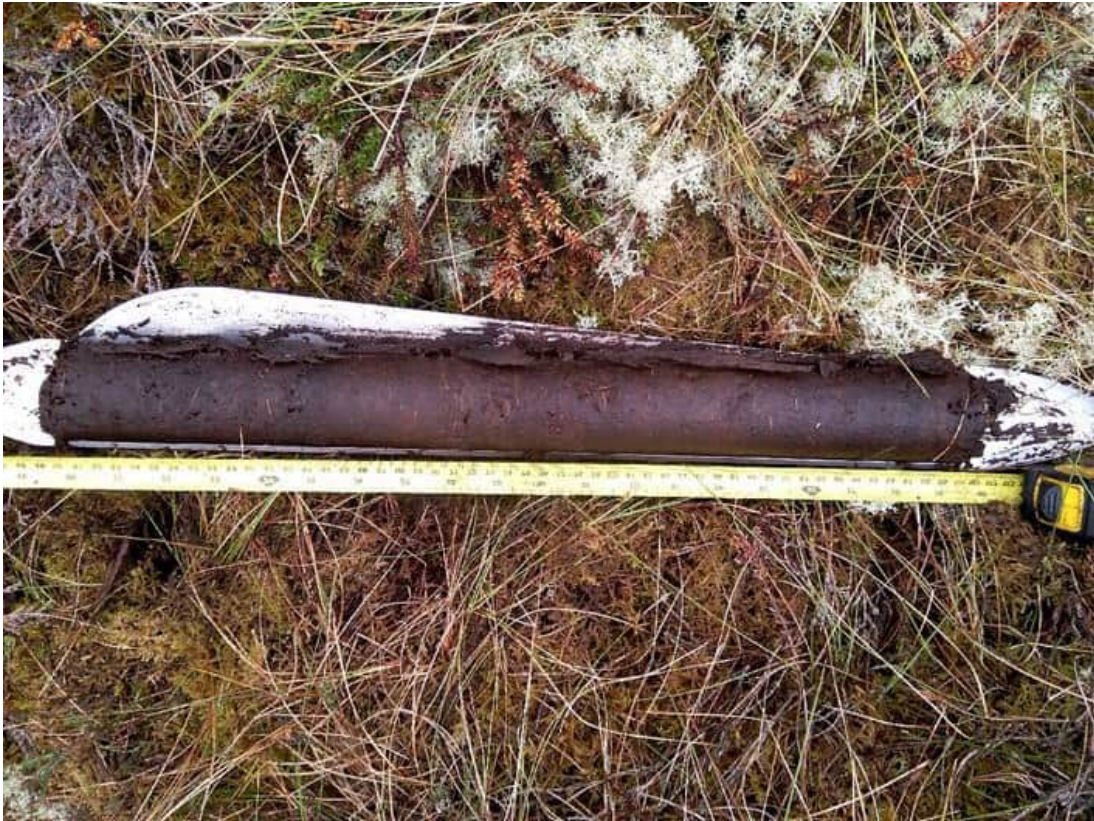
| ID: | Photo 2 | Von Post Classification: | H3 |

| Location: | 270426, 634279 | Underlying Substrate: | N/A |
| Description: | Auger Location 1 | Logged By: | BN / AD |
| Depth (m): | 0.5-1.0 | Date: | 24/05/2024 |

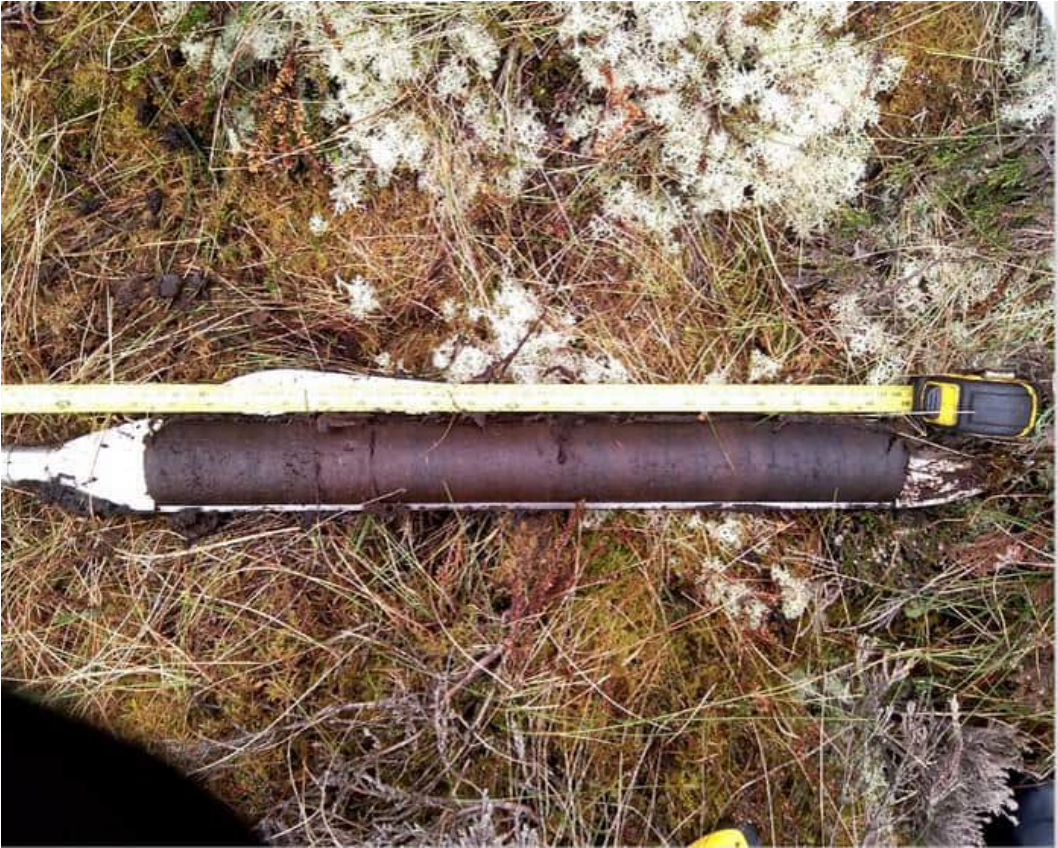
| ID: | Photo 3 | Von Post Classification: | H3/H4 |

| Location: | 270426, 634279 | Underlying Substrate: | N/A |
| Description: | Auger Location 1 | Logged By: | BN / AD |
| Depth (m): | 1 – 1.5 | Date: | 24/05/2024 |

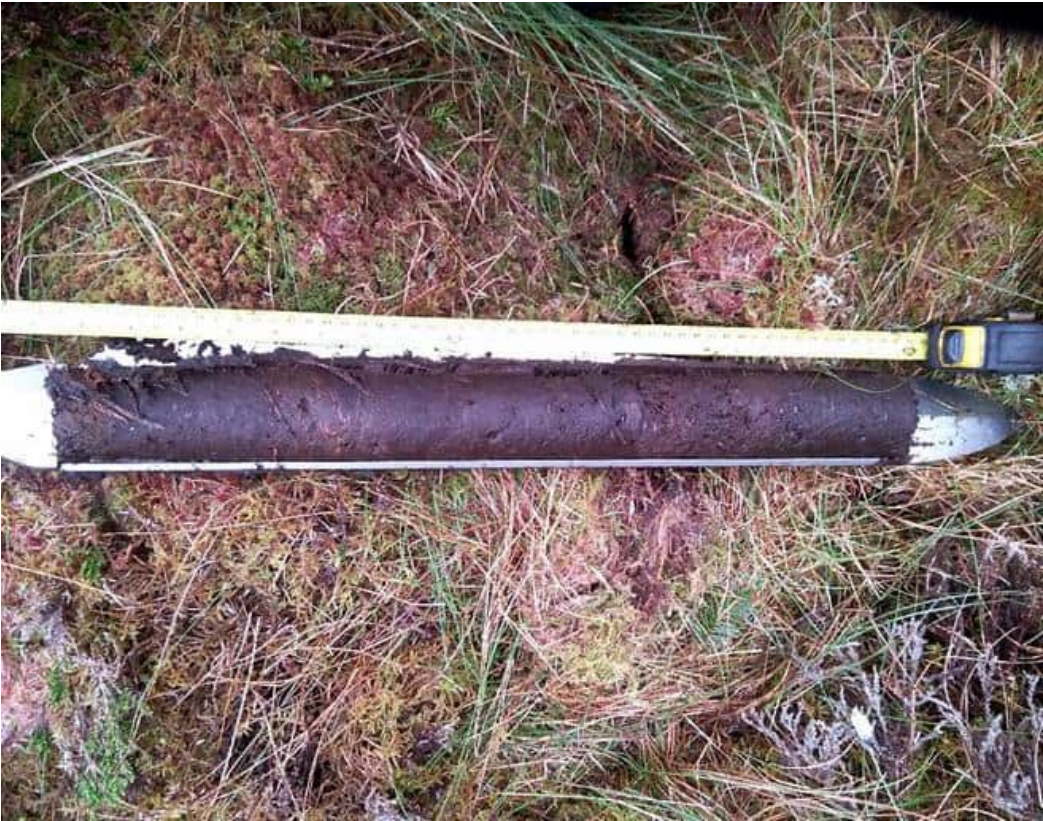
| ID: | Photo 1 | Von Post Classification: | H2 |

| Location: | 270187, 634417 | Underlying Substrate: | N/A |
| Description: | Auger Location 2 | Logged By: | BN / AD |
| Depth (m): | 0 – 0.5 | Date: | 24/05/2024 |

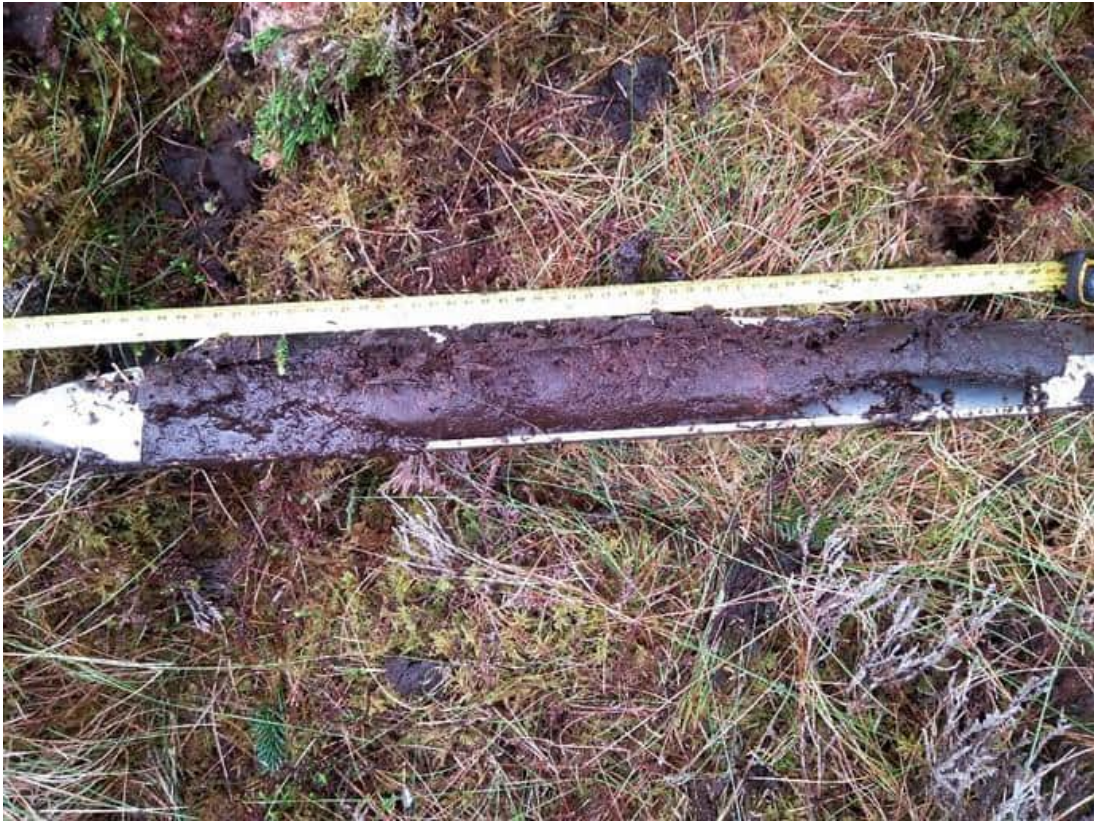
| ID: | Photo 2 | Von Post Classification: | H3 |

| Location: | 270187, 634417 | Underlying Substrate: | N/A |
| Description: | Auger Location 2 | Logged By: | BN / AD |
| Depth (m): | 0.5-1.0 | Date: | 24/05/2024 |

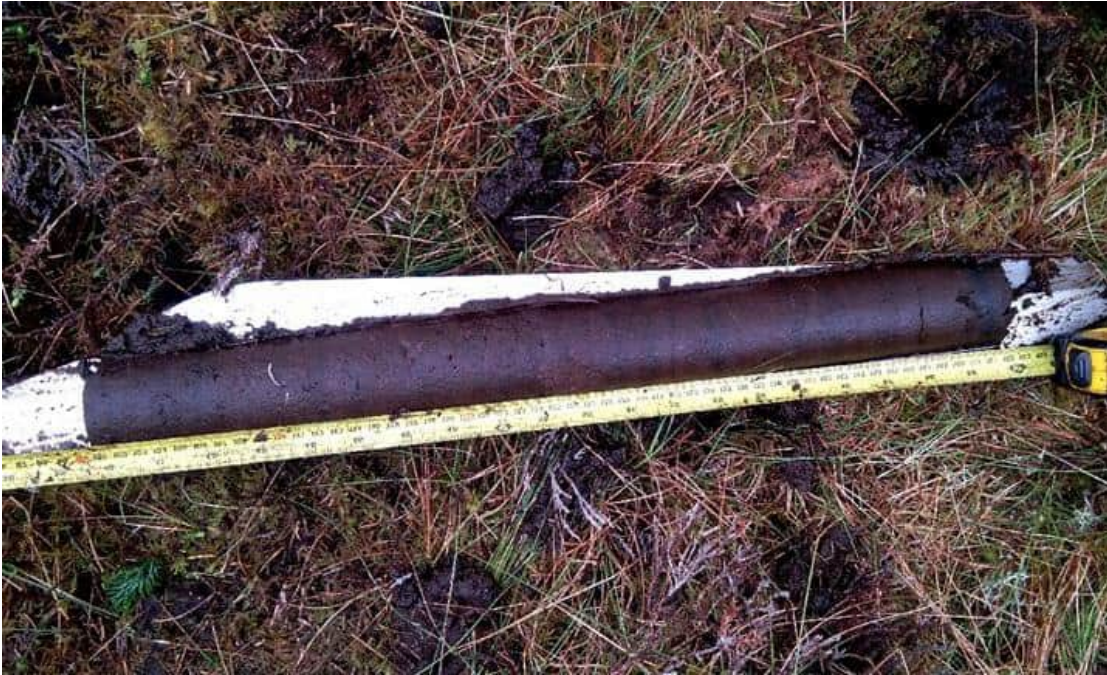
| ID: | Photo 3 | Von Post Classification: | H3/4 |

| Location: | 270187, 634417 | Underlying Substrate: | N/A |
| Description: | Auger Location 2 | Logged By: | BN / AD |
| Depth (m): | 1.0 – 1.5 | Date: | 24/05/2024 |

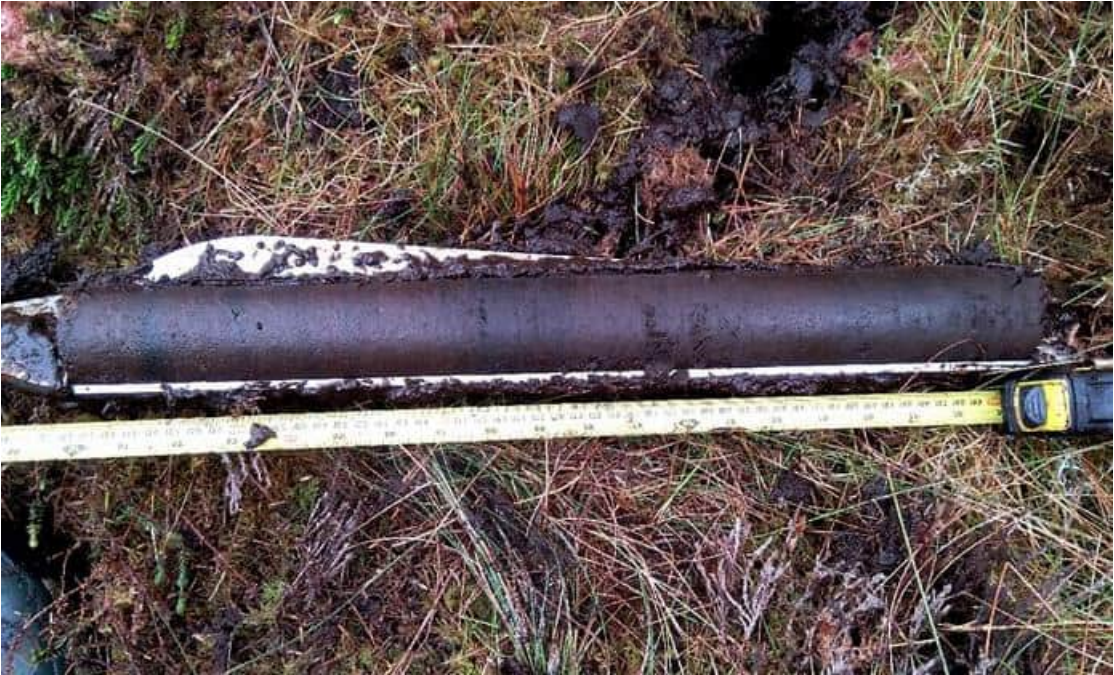
| ID: | Photo 4 | Von Post Classification: | H3/4 |

| Location: | 270187, 634417 | Underlying Substrate: | N/A |
| Description: | Auger Location 2 | Logged By: | BN / AD |
| Depth (m): | 1.5 – 2.0 | Date: | 24/05/2024 |

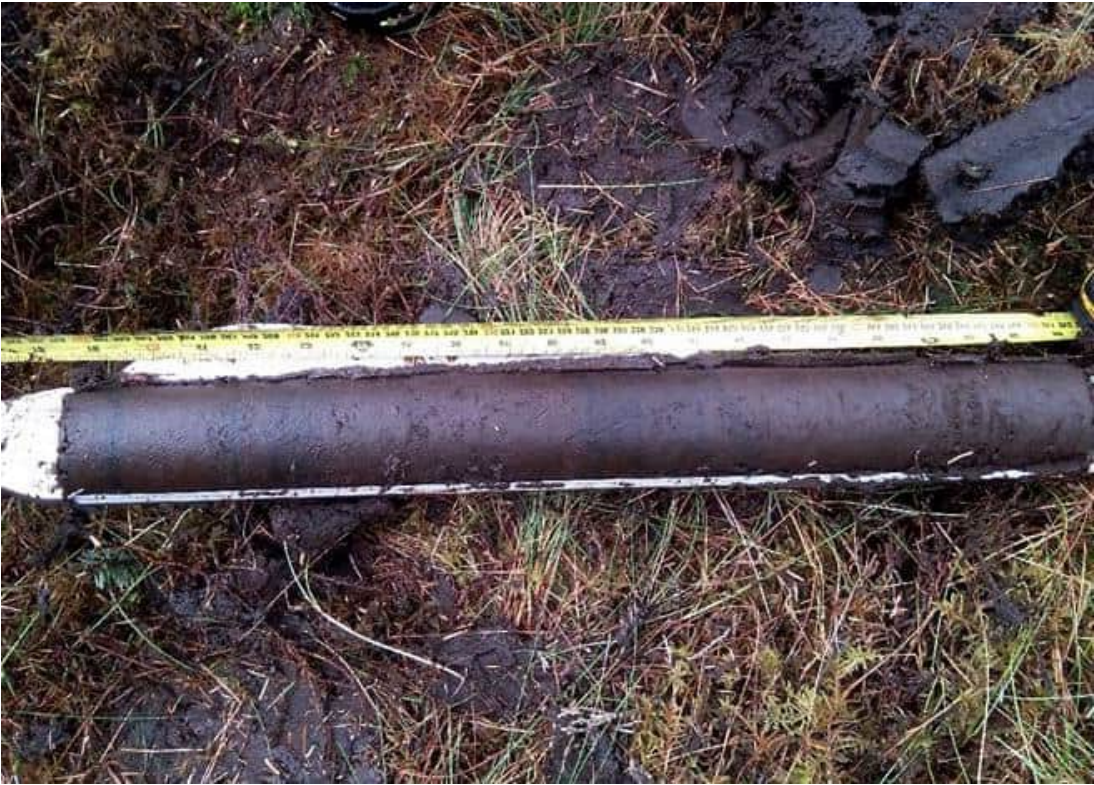
| ID: | Photo 5 | Von Post Classification: | H4/5 |

| Location: | 270187, 634417 | Underlying Substrate: | N/A |
| Depth (m): | 2.0 – 2.5 | Date: | 24/05/2024 |

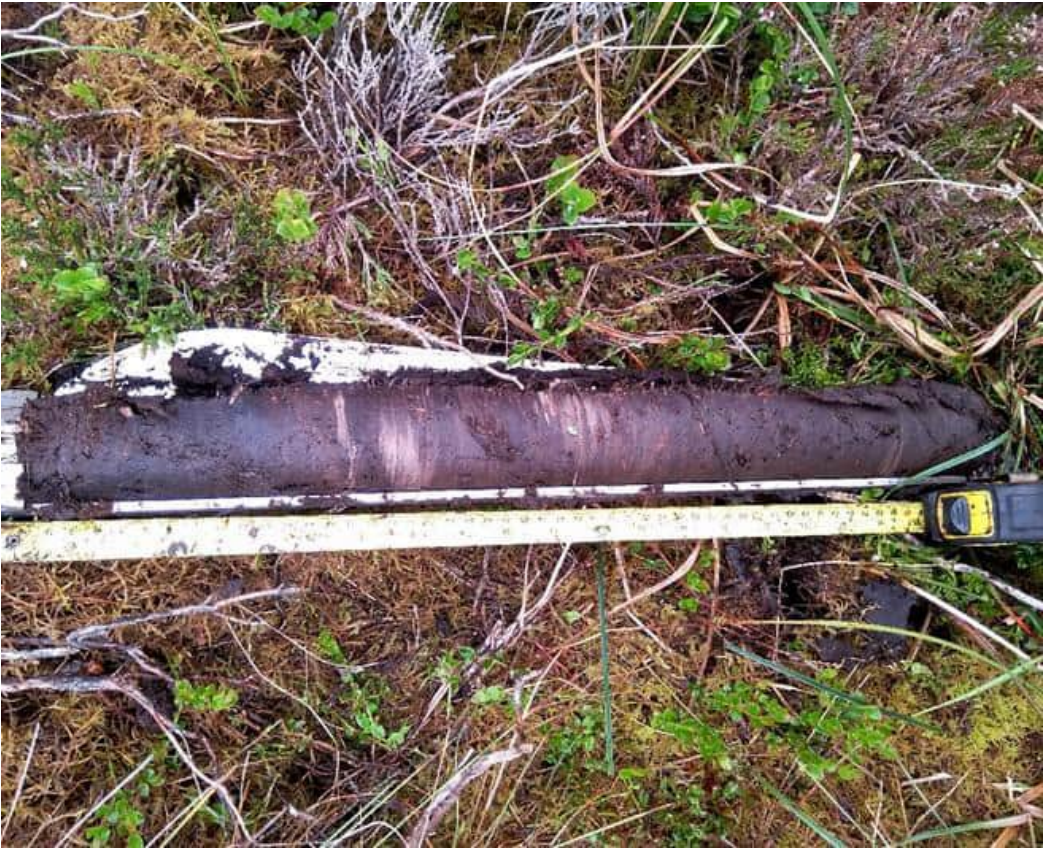
| ID: | Photo 1 | Von Post Classification: | H2 |

| Location: | 269547, 634298 | Underlying Substrate: | N/A |
| Description: | Auger Location 3 | Logged By: | BN / AD |
| Depth (m): | 0 – 0.5 | Date: | 24/05/2024 |

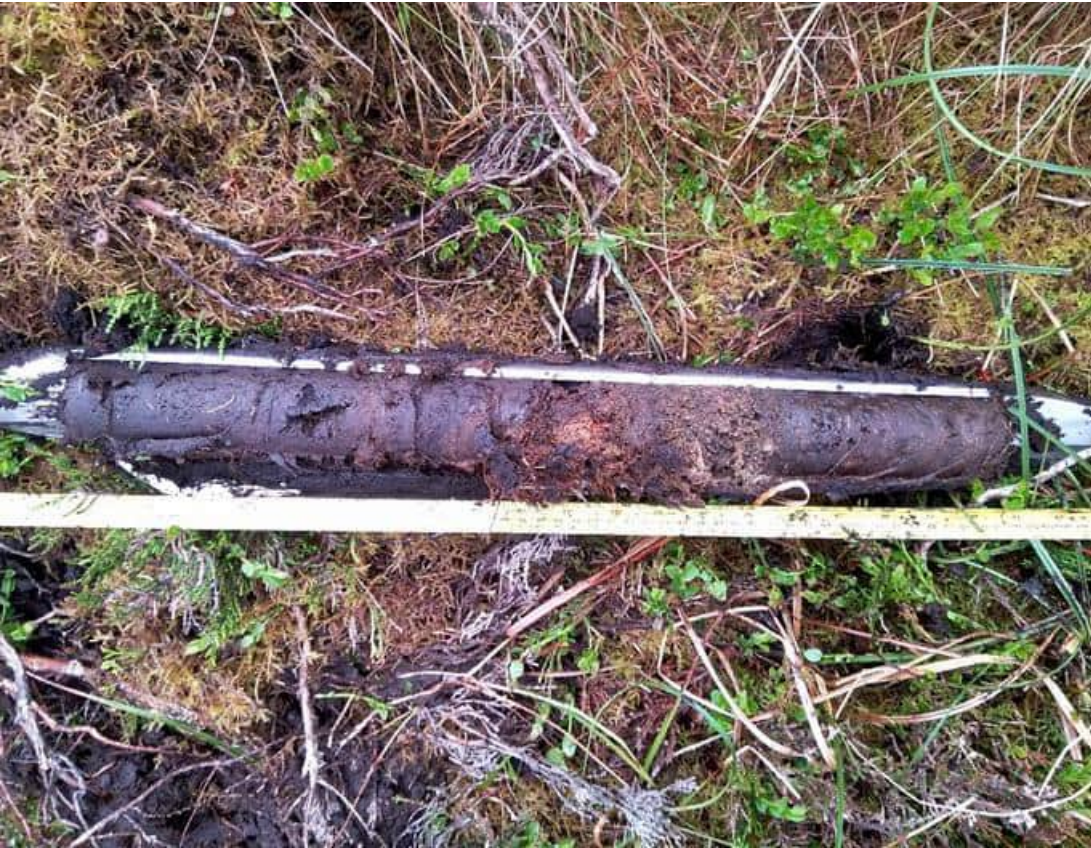
| ID: | Photo 2 | Von Post Classification: | H2 |

| Location: | 269547, 634298 | Underlying Substrate: | N/A |
| Description: | Auger Location 3 | Logged By: | BN / AD |
| Depth (m): | 0.5-1.0 | Date: | 24/05/2024 |

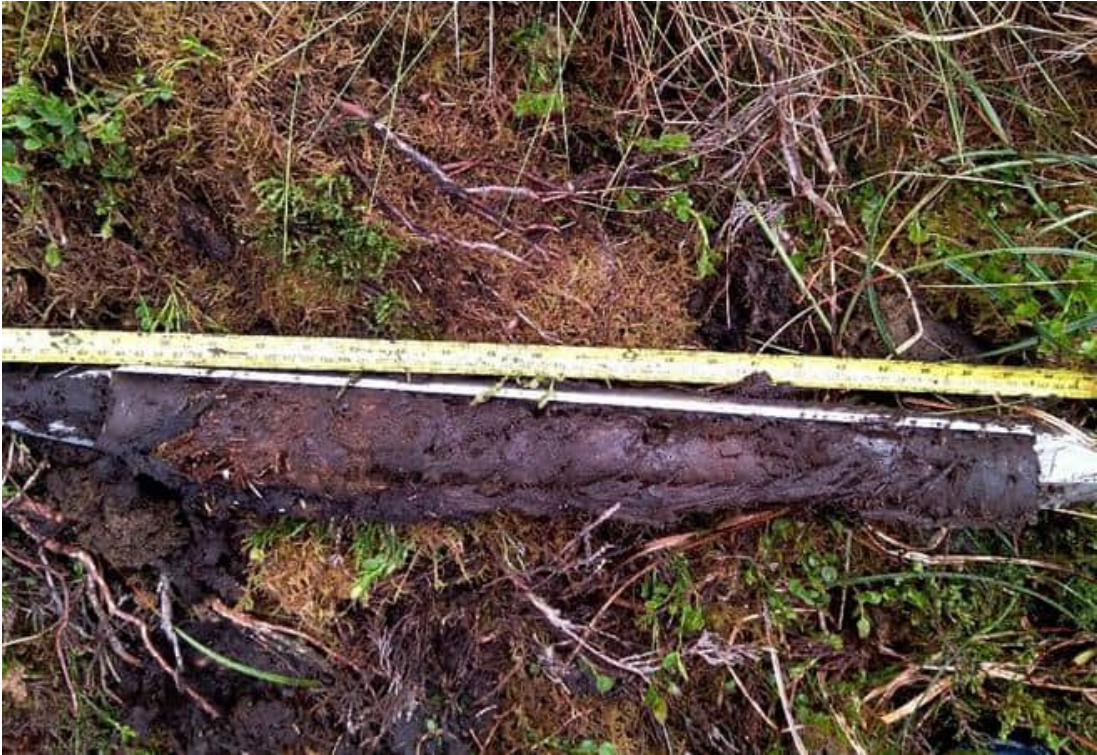
| ID: | Photo 3 | Von Post Classification: | H2 |

| Location: | 269547, 634298 | Underlying Substrate: | N/A |
| Description: | Auger Location 3 | Logged By: | BN / AD |
| Depth (m): | 1 – 1.5 | Date: | 24/05/2024 |

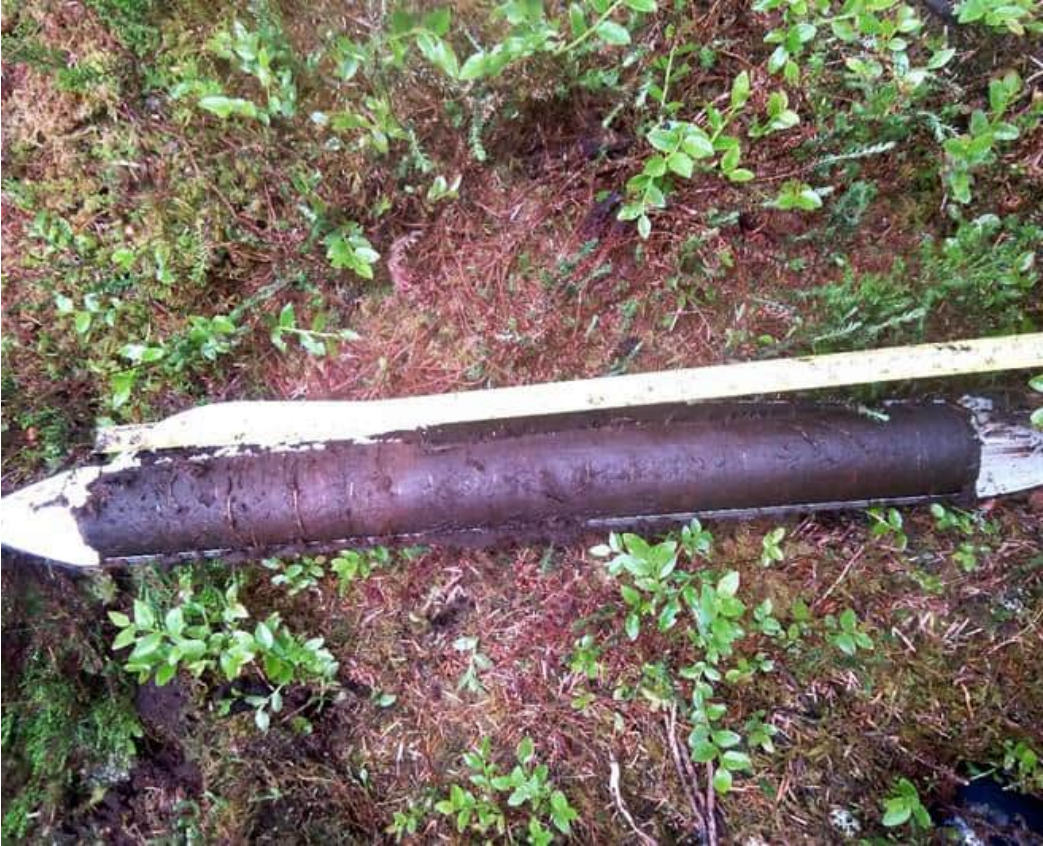
| ID: | Photo 1 | Von Post Classification: | H2 |

| Location: | 269293, 633901 | Underlying Substrate: | N/A |
| Description: | Auger Location 4 | Logged By: | BN / AD |
| Depth (m): | 0 – 0.5 | Date: | 24/05/2024 |

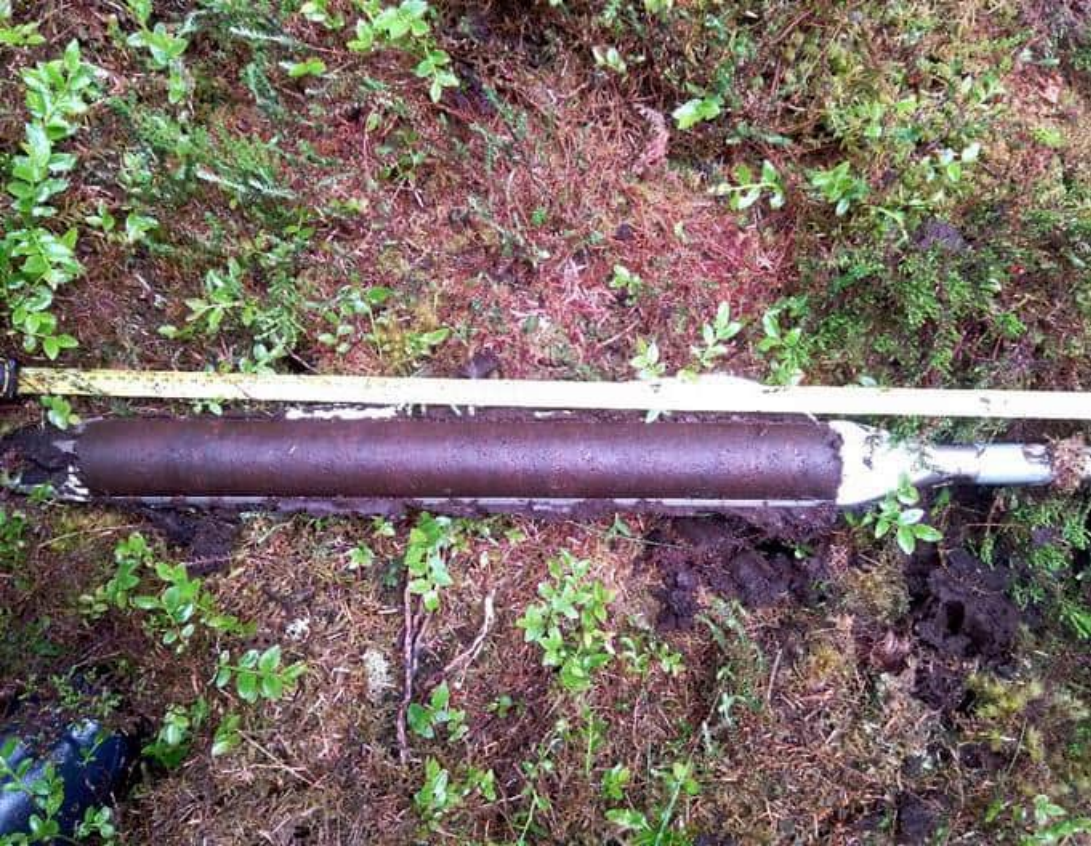
| ID: | Photo 2 | Von Post Classification: | H2/3 |

| Location: | 269293, 633901 | Underlying Substrate: | N/A |
| Description: | Auger Location 4 | Logged By: | BN / AD |
| Depth (m): | 0.5-1.0 | Date: | 24/05/2024 |

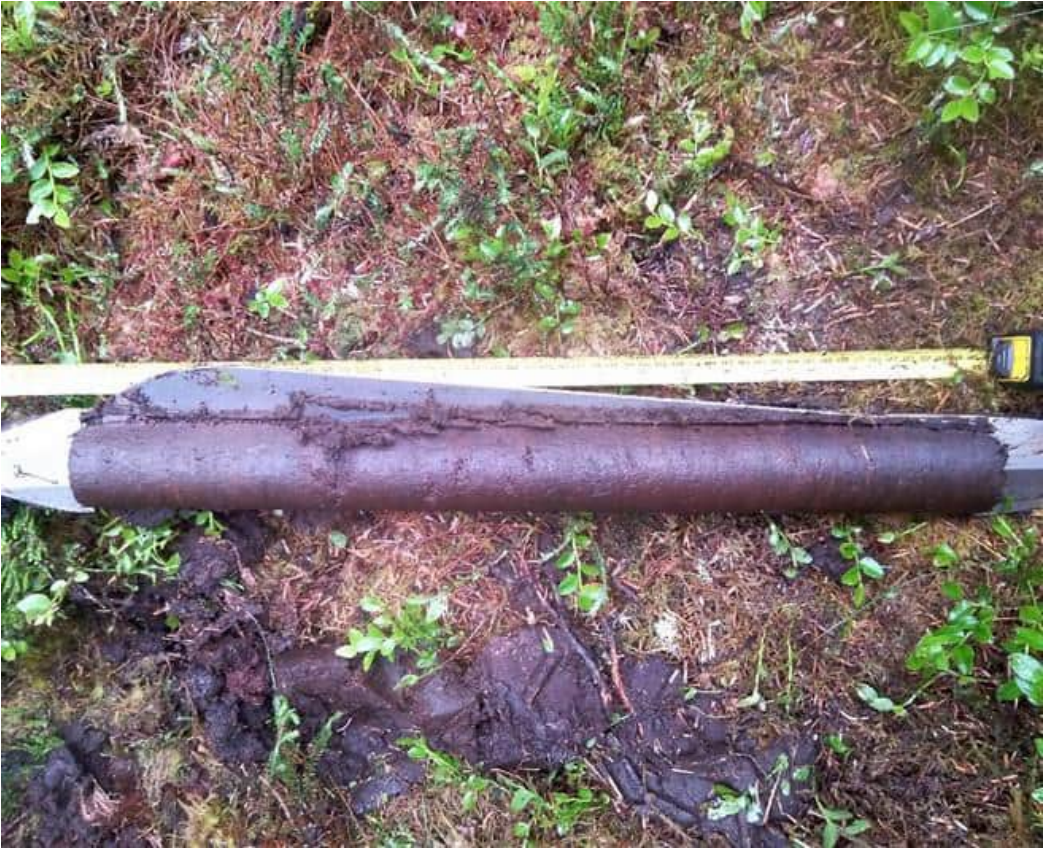
| ID: | Photo 3 | Von Post Classification: | H3 |

| Location: | 269293, 633901 | Underlying Substrate: | N/A |
| Description: | Auger Location 4 | Logged By: | BN / AD |
| Depth (m): | 1 – 1.5 | Date: | 24/05/2024 |

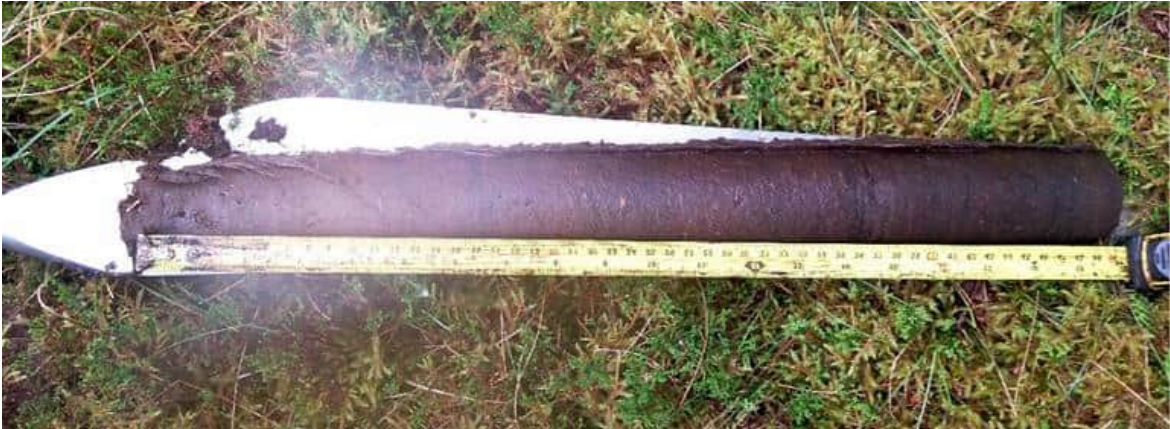
| ID: | Photo 1 | Von Post Classification: | H2 |

| Location: | 268193, 634721 | Underlying Substrate: | N/A |
| Description: | Auger Location 5 | Logged By: | BN / AD |
| Depth (m): | 0 – 0.5 | Date: | 24/05/2024 |

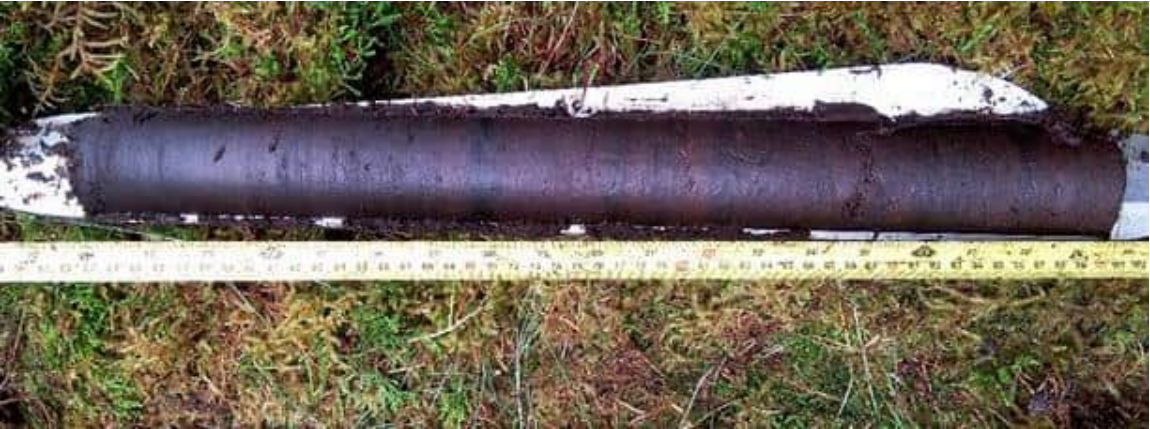
| ID: | Photo 2 | Von Post Classification: | H2/3 |

| Location: | 268193, 634721 | Underlying Substrate: | N/A |
| Description: | Auger Location 5 | Logged By: | BN / AD |
| Depth (m): | 0.5-1.0 | Date: | 24/05/2024 |

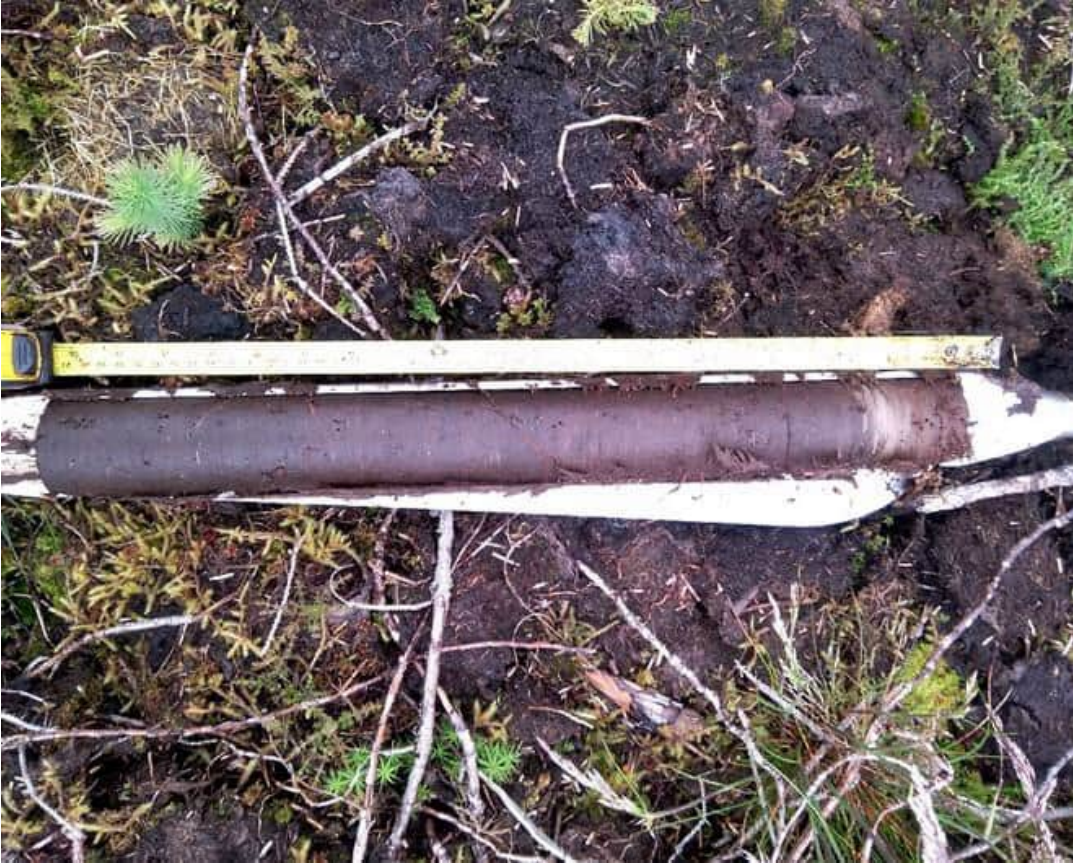
| ID: | Photo 1 | Von Post Classification: | H2 |

| Location: | 267902, 634005 | Underlying Substrate: | N/A |
| Description: | Auger Location 6 | Logged By: | BN / AD |
| Depth (m): | 0 – 0.5 | Date: | 24/05/2024 |

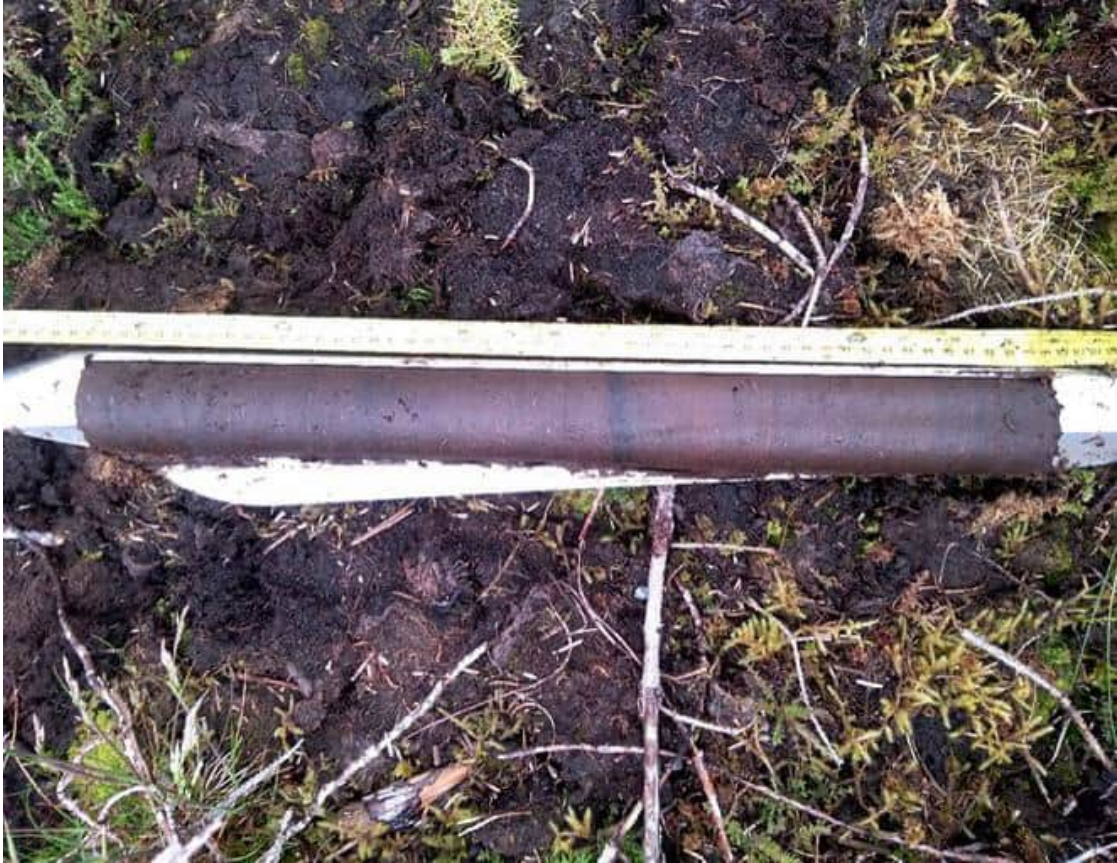
| ID: | Photo 2 | Von Post Classification: | H2 |

| Location: | 267902, 634005 | Underlying Substrate: | N/A |
| Depth (m): | 0.5-1.0 | Date: | 24/05/2024 |

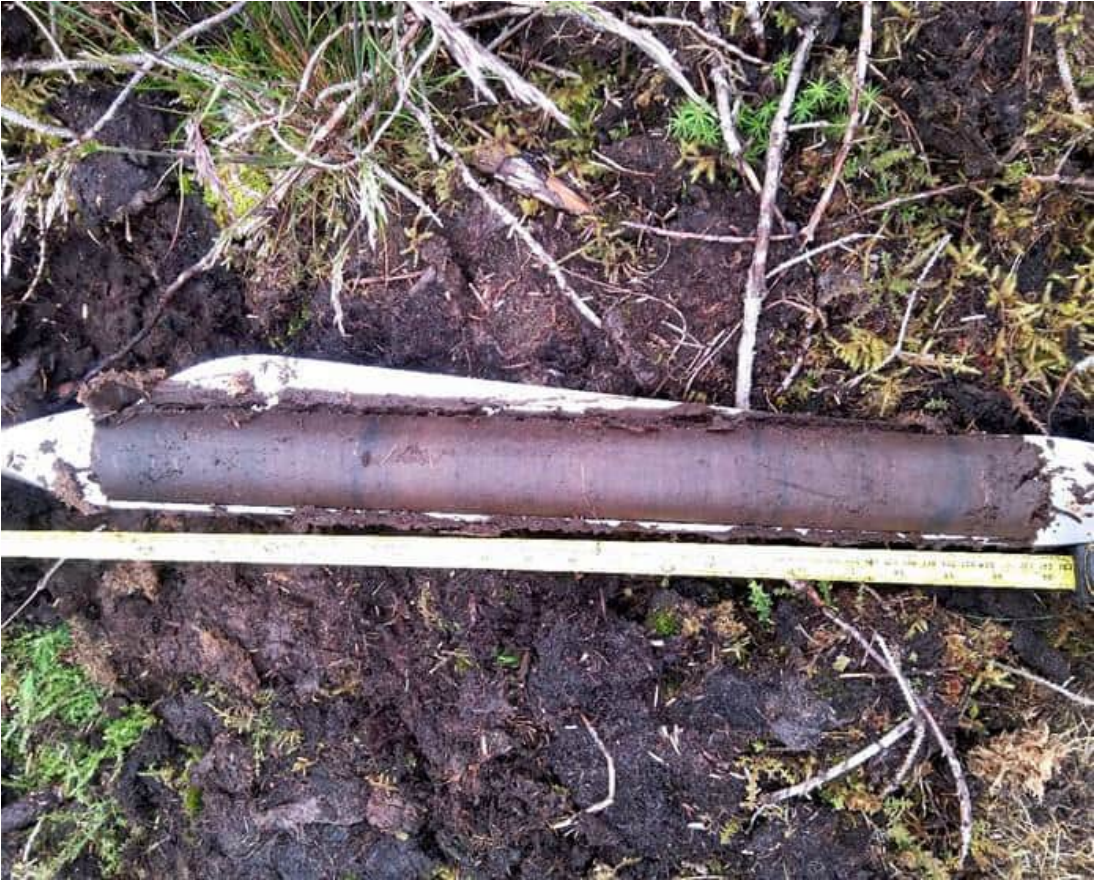
| ID: | Photo 3 | Von Post Classification: | H2/H3 |

| Location: | 267902, 634005 | Underlying Substrate: | N/A |
