# **Technical Appendix 8.2**

## **Private Water Supply Risk Assessment**

# Private Water Supply Risk Assessment

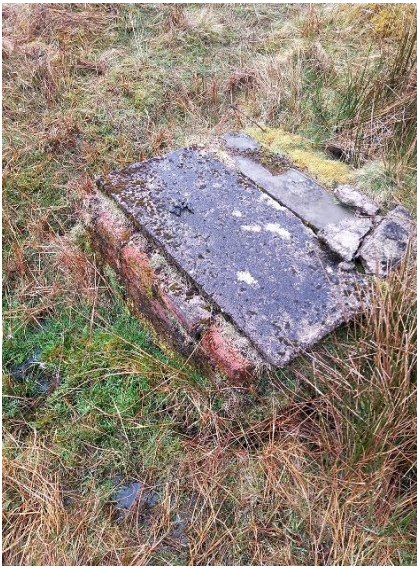
| Source Ref | Source Name | Photograph |
|---|---|---|
| PWS03 | Linburn | |

- 1.5.3 Following consultation with the landowner of Linburn Farm prior to and during the site visit, it was confirmed that the property and Blackside House are supplied by a spring. The spring is confirmed to be located at a source tank at NGR 268343 629821. As shown in **Annex 3 Table 3**, the tank is brick lined with a steel top, with pipes into the surrounding hillside. The supply is then piped downhill and supplies Linburn Farm and Blackside House, approx. 1.2 km and 1.7 km downslope, where it is used for drinking, domestic and livestock purposes. The approximate route of the pipework from the tank to the properties was outlined by the landowner of Linburn Farm during the site visit, as shown in **TA8.2 Figure 5**. The supply pipework crosses into the site at approximately NGR 268544, 299695.

- 1.5.4 Underlying bedrock consists of sandstone of the Leaze Formation, with no mapped underlying superficial deposits, although till deposits are present immediately upslope. The spring source is underlain by low productivity bedrock aquifer of Silurian Rocks (Undifferentiated). Groundwater within the bedrock aquifer is described to be limited with flow through fractures or present in near-surface weathered zone.

- 1.5.5 Due to its infrastructure and surrounding geology, it is likely to be predominantly supplied by near-surface groundwater that will largely follow topography, with minimal deeper groundwater influence.

- 1.5.6 As shown in **TA8.2 Figure 5**, the spring is located approximately 160 m upslope from the nearest Proposed Development infrastructure, and is located outwith SEPA groundwater abstraction 10 m, 100 m and 250 m infrastructure buffers. The supply pipework is however considered likely to be located within these buffers and underlying Proposed Development infrastructure in areas. Embedded mitigation has been implemented as far as practicable through the iterative design of the Proposed Development, and infrastructure has been sited as far as practicable from the PWS source and supply pipework, while considering other constraints.

- 1.5.7 It is considered that the supply pipework of PWS03 is at increased potential risk during construction of the solar panels, security fence and new tracks associated with the southern development area. The location of the pipe between the source tank and the properties supplied, was not visible during the site walkover. It may cross under the current Proposed Development, however, this has not been confirmed and is based on approximate locations provided by the landowner of Linburn Farm.

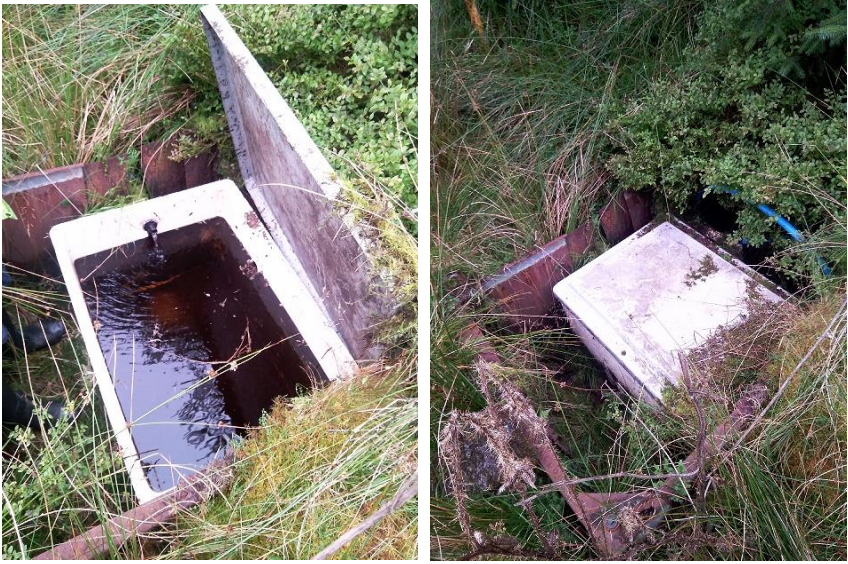
| Source Ref | Source Name | Photograph |
|---|---|---|
| PWS08 | Glengavel | |

- 1.5.9 Following consultation with the resident prior to and during the site visit, it is confirmed that the property is supplied by a spring source. The spring source tank is located at NGR 265673, 633257, with the source located upslope of this. As shown in **Annex 3 Table 3**, there is a steel tank with plastic blue pipes into the surrounding hillside. The supply is then gravity fed and piped approx. 630 m downhill and supplies the property, where it is used for drinking and domestic purposes.

- 1.5.10 The approximate route of the pipework from holding tank to property was outlined by the resident during the site visit, with the approximate location of the supply pipework shown in **TA8.2 Figure 5**.

- 1.5.11 The spring is underlain by the low productivity bedrock aquifer of the Silurian Rocks (Undifferentiated), where there is limited groundwater present in near-surface weathered zone and flow is largely through fractures and discontinuities. The spring is within sandstone bedrock of the Plewland Formation, with a fault present approx. 100 m to the north-west. The spring is located on slopes with no mapped superficial deposits, immediately upslope of till deposits. Upslope on Dungavel Hill to the east, deposits of peat and deep peat are present.

- 1.5.12 There is a minor surface watercourse in close proximity to the source which flows downslope from the steep forested slopes of Dungavel Hill. PWS08 is located within the same sub-catchment as the Proposed Development, Bught Burn which is a tributary of Glengavel Water. PWS08 is located upslope of all Proposed Development infrastructure within the same catchment, and there is no infrastructure within its source catchment, as shown in **TA8.2 Figure 5**.

- 1.5.15 It is considered that the pipework of PWS08 is at increased potential risk during construction of the access tracks and temporary hardstanding of T2. The location of the pipe between the source tank and the property supplied was not visible during the site walkover, except where visible underlying the upgraded forestry access track. From the residents description and pipework visible onsite, it will likely cross under the Proposed Development, however, this has not currently been confirmed.

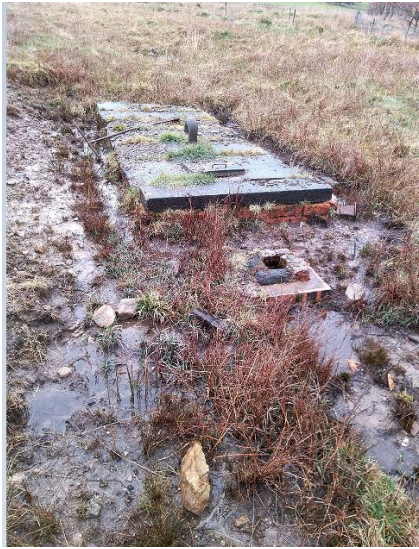
| Source Ref | Source Name | Photograph |
|---|---|---|
| PWS13 | Laigh Hall | |

- 1.5.17 Consultation with the landowner of Laigh Hall prior to the site visit confirmed PWS13 to be a spring which supplies the property. The supply is treated with a UV filter, and is no longer shared with Upper Hall as the property is abandoned and derelict.

- 1.5.18 Consultation with a nearby landowner confirmed the spring to be located at a source tank at NGR 268147, 628995, approx. 600 m north-west of Laigh Hall. As shown in **Annex 3 Table 3**, the tank is brick lined with a steel top, with pipes into the surrounding hillside. The supply is piped from the tank to a tap south of the source at NGR 268191, 628888 and to the property at NGR 267863, 628503. The location of the pipework was not visible during the site walkover, an approximate location of the pipework based on consultation with the landowner is shown in **TA8.2 Figure 5**.

- 1.5.19 The spring is underlain by the moderately productive bedrock aquifer of the Inverclyde Group, which is a multi-layered aquifer where flow is mostly through fractures. The spring is located in close proximity to an igneous intrusion of the Mull Dyke Swarm. Mapped superficial deposits of till are also shown underlying the source. The source is located in close proximity to a nearby watercourse.

- 1.5.21 As shown in **TA8.2 Figure 5**, the spring is located approximately 50 m downslope of the nearest Proposed Development infrastructure, and is located outwith SEPA groundwater abstraction 10 m, 100 m and 250 m infrastructure buffers.

- 1.5.24 It is considered that the pipework of PWS13 is at increased potential risk during construction of the solar PV modules. The location of the pipe between the tank and the property supplied was not visible during the site walkover. It may cross under the Proposed Development, however, this has not been confirmed and is based on approximate locations provided by the nearby landowner.
